Appendix F – Photo Log

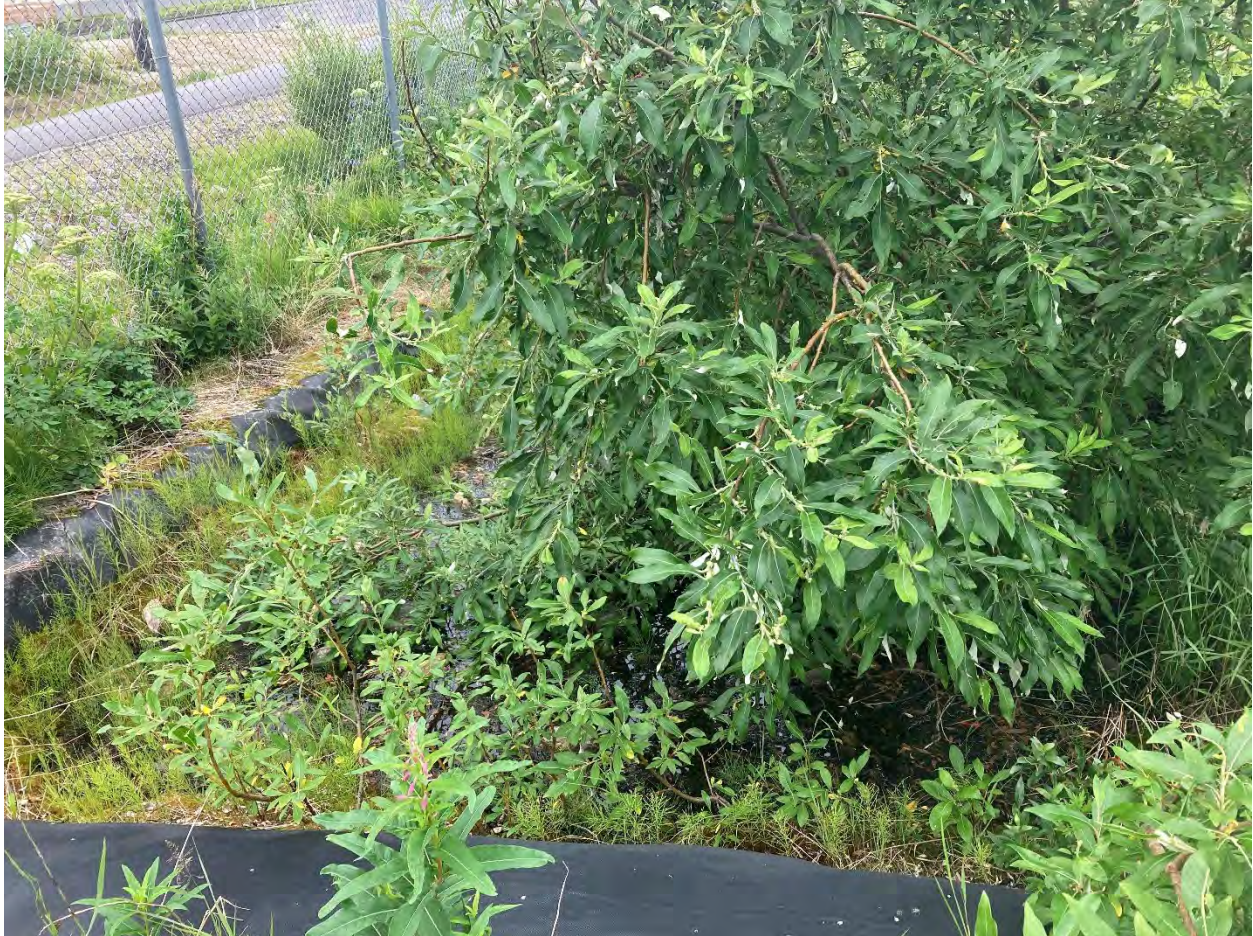
0718ELM09 – Standing water at southwestern edge of tank farm footprint

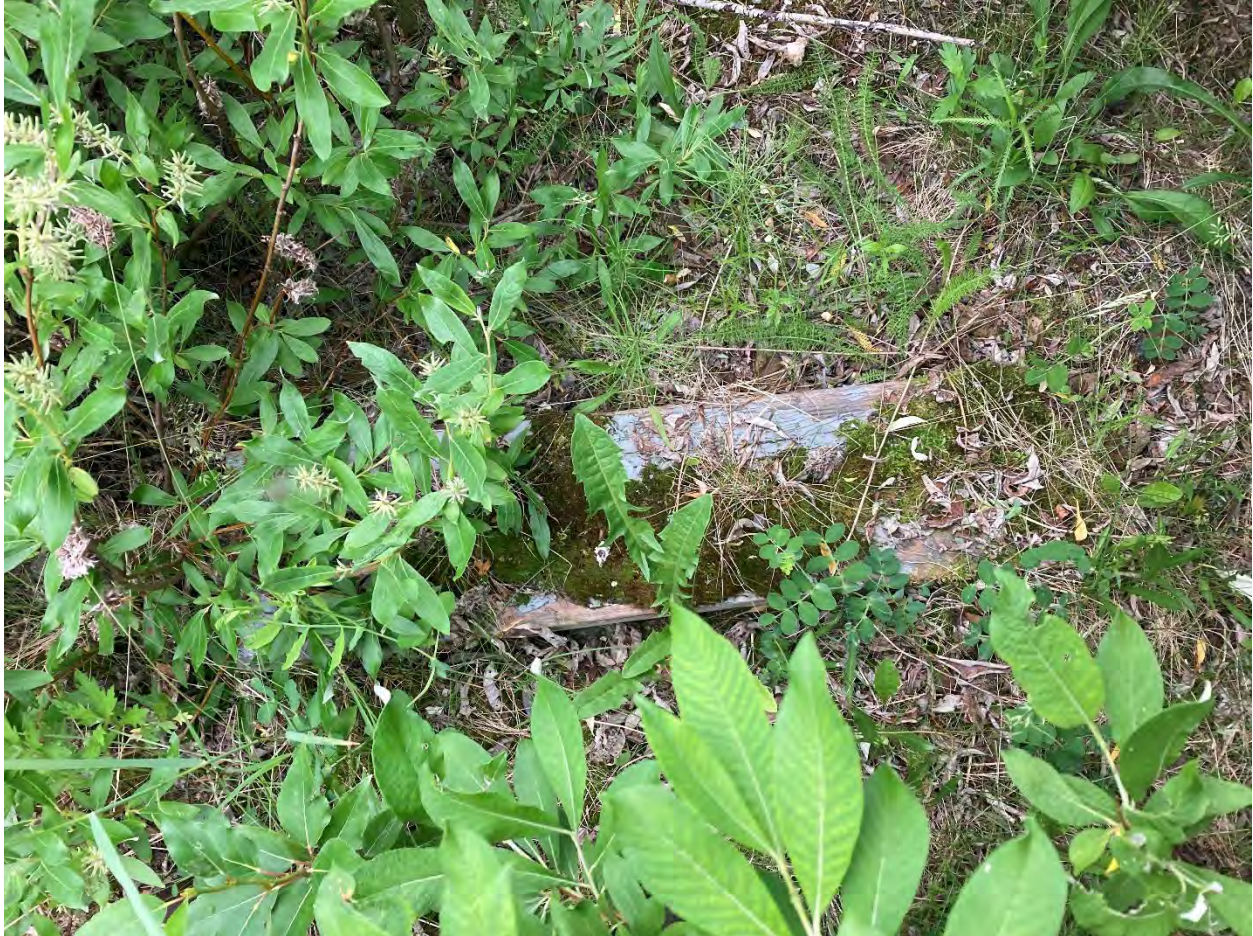
0718ELM10 – wood debris with potential lead paint chips
outside of tank farm footprint, on northern area of site

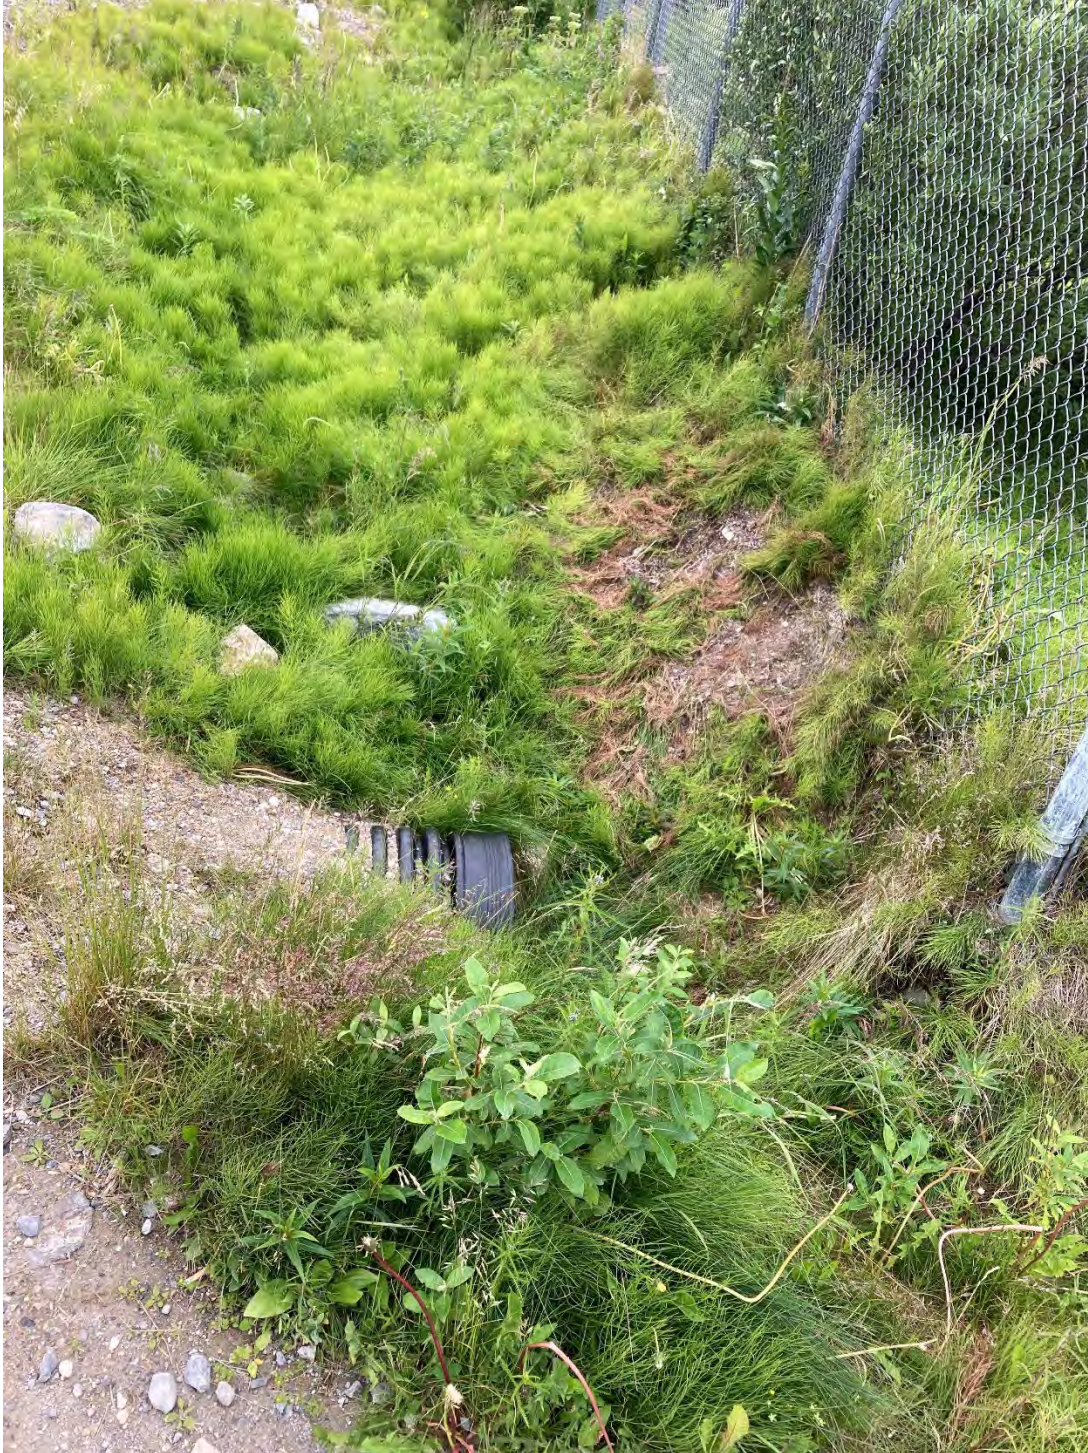
0718ELM12 – Suspected drainage pipe outside of site boundaries, at eastern corner of site

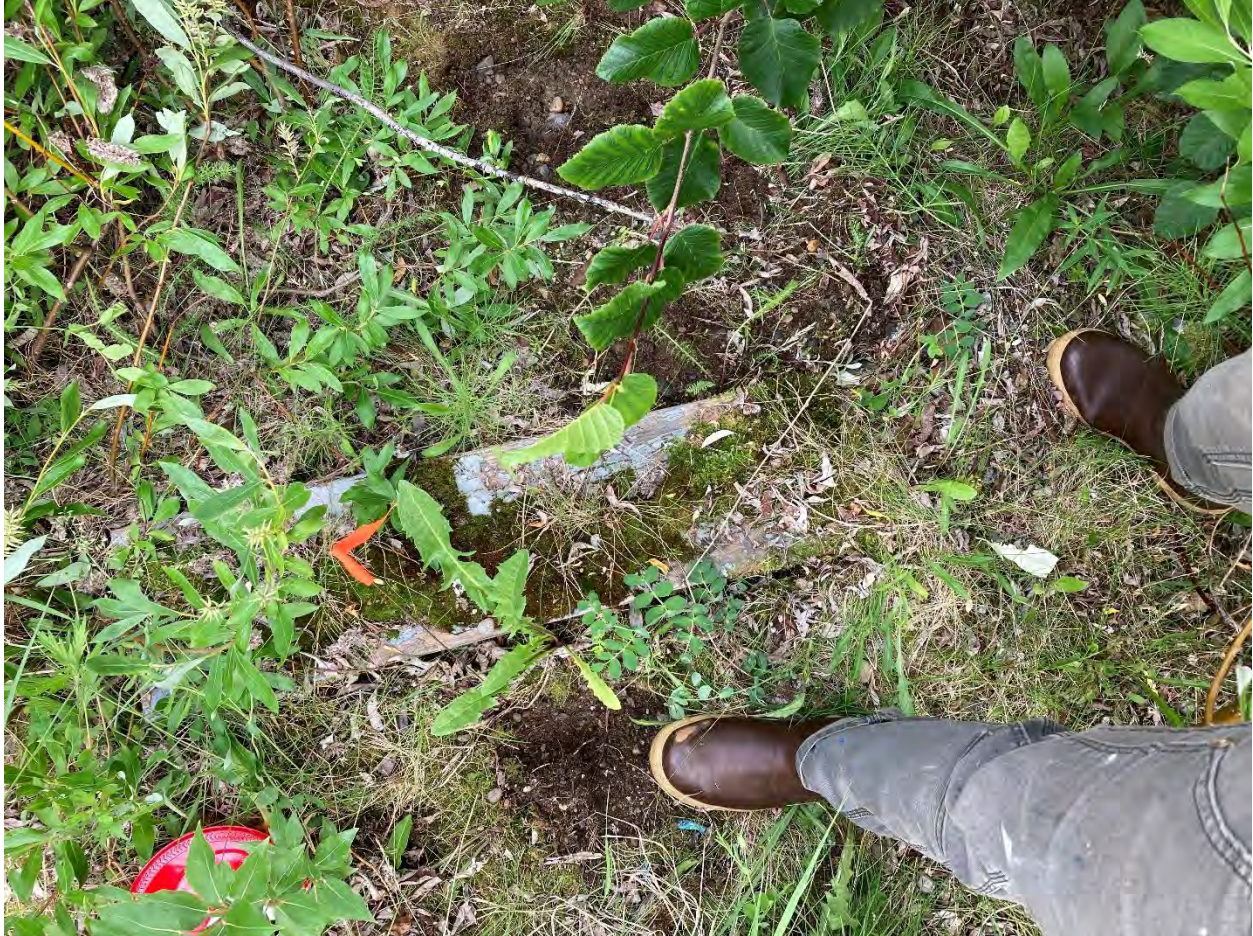
0718ELM28 – Debris by drum area northeast of the tank farm

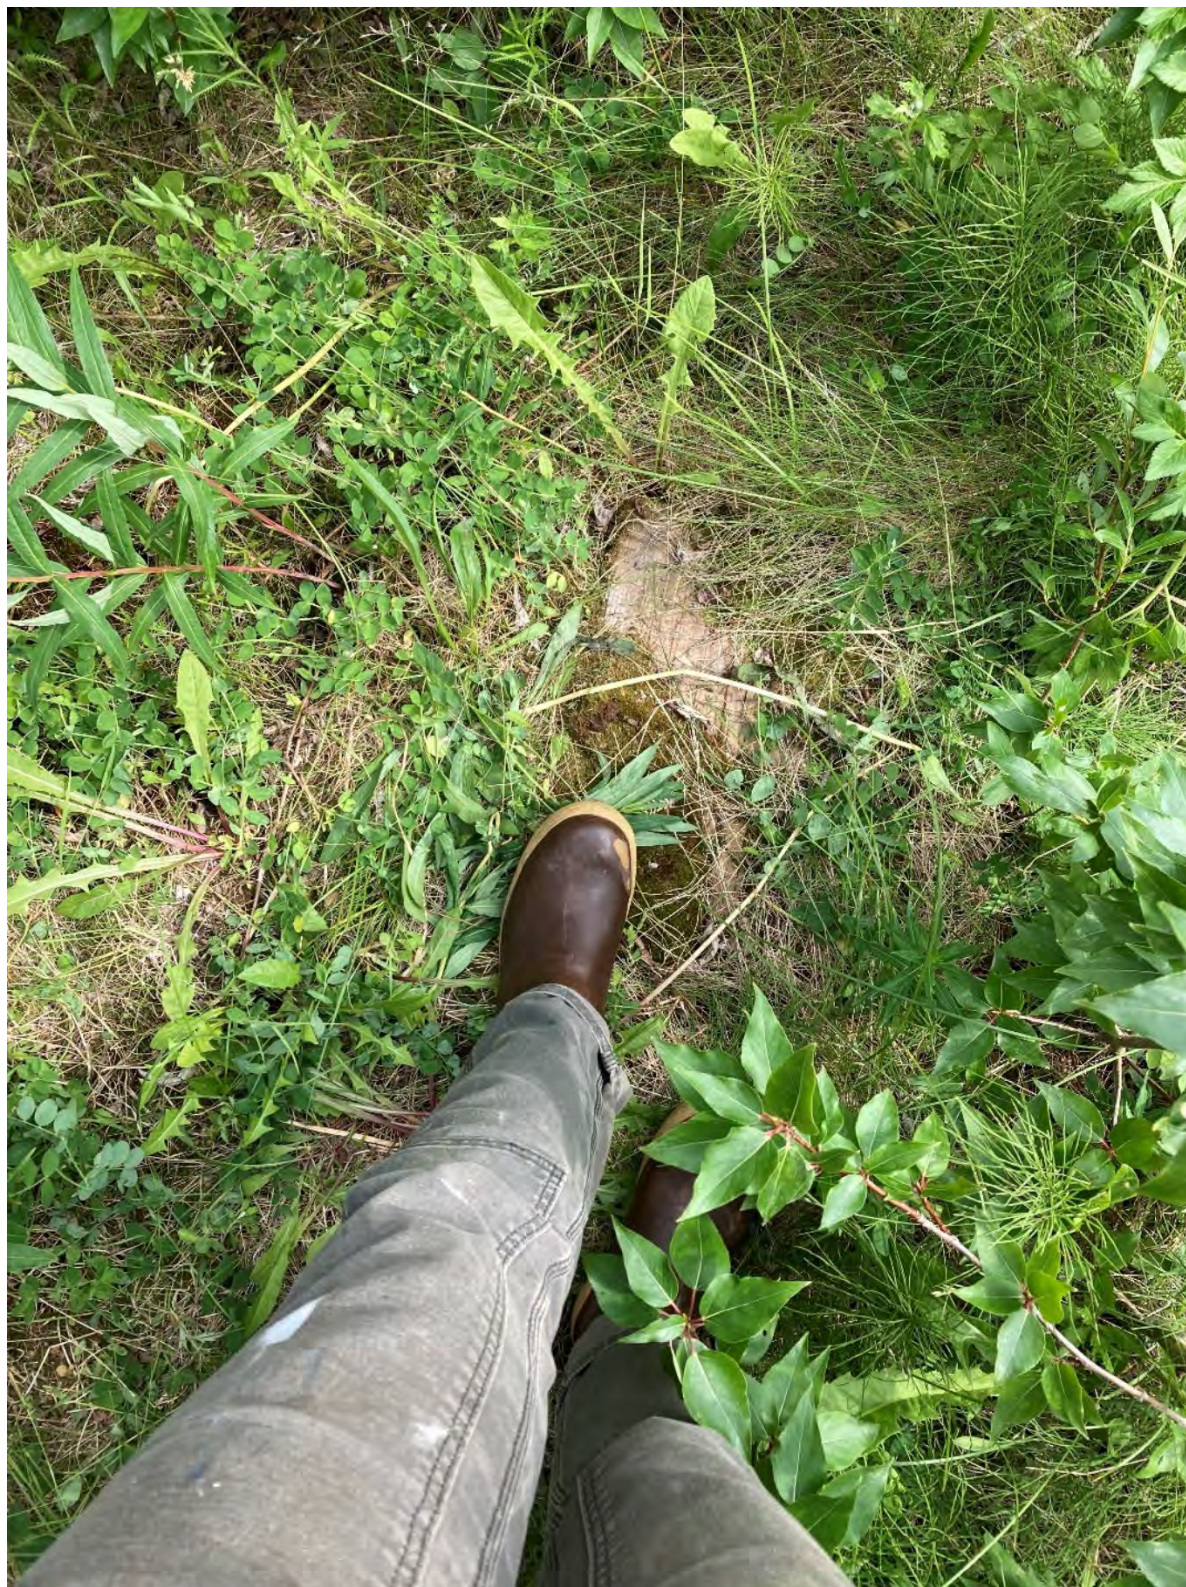
0718ELM29 – Debris by drum area northeast of the tankfarm

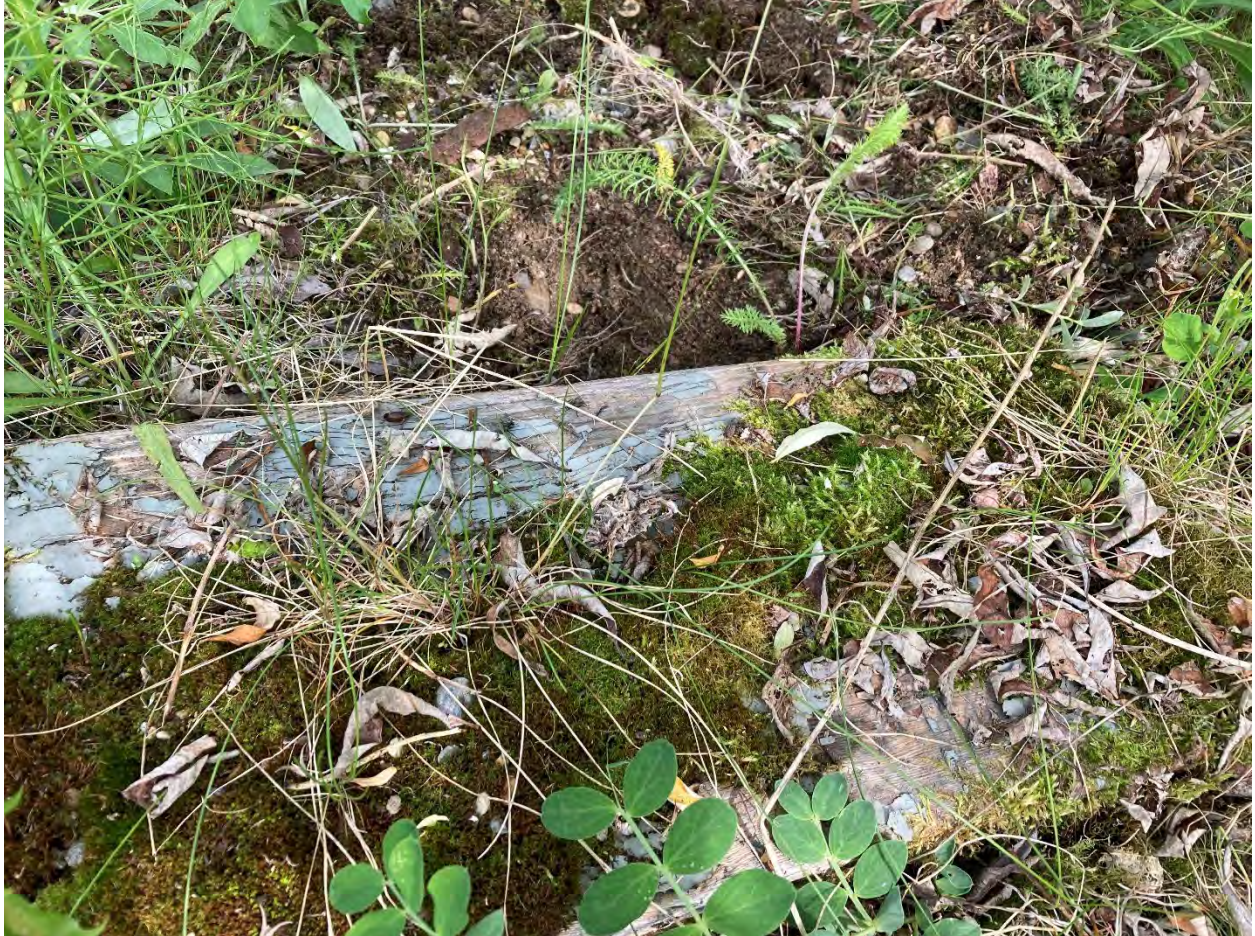
0718ELM33 - Debris by drum area northeast of the tank farm

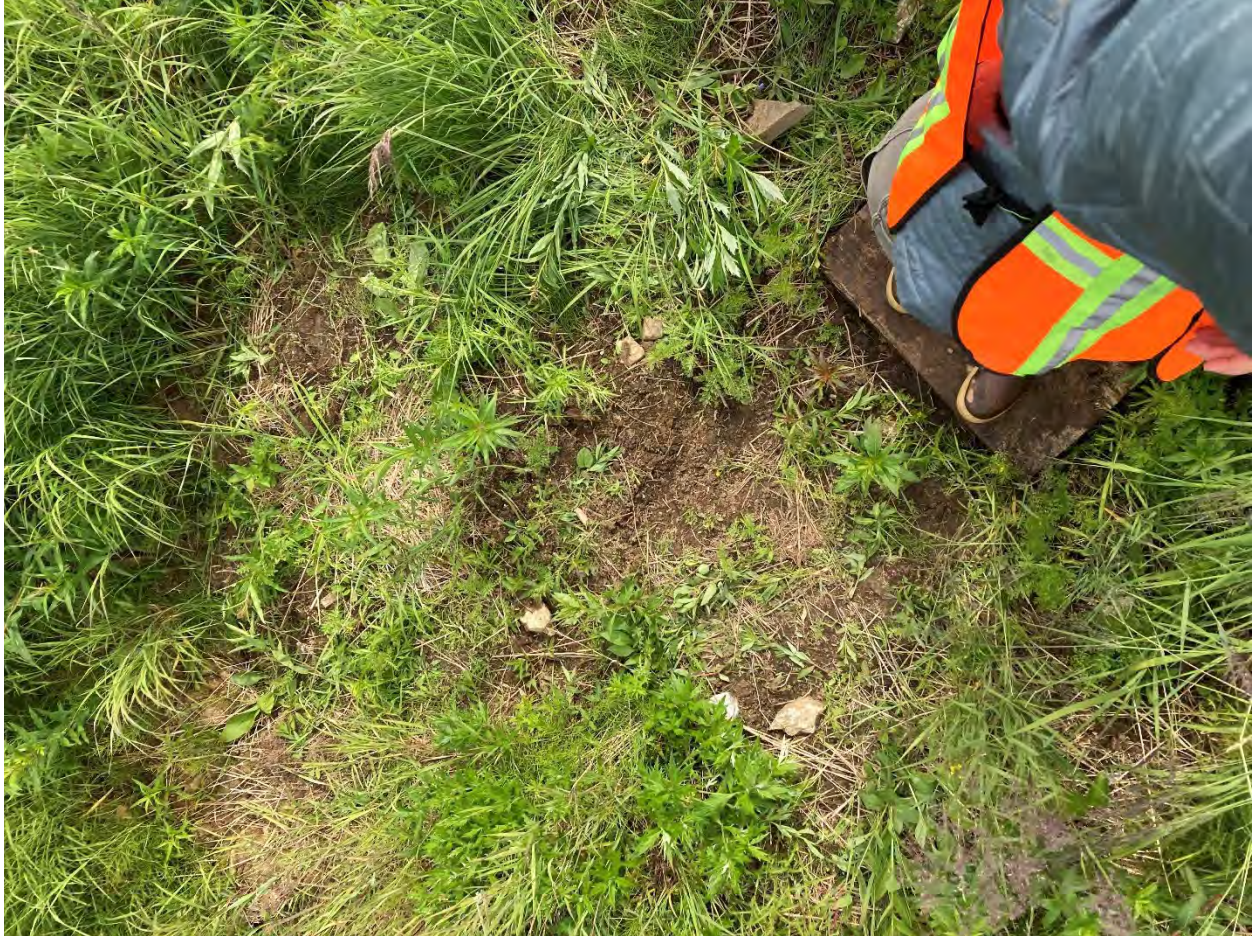
0718ELM34 – Area of stained soil

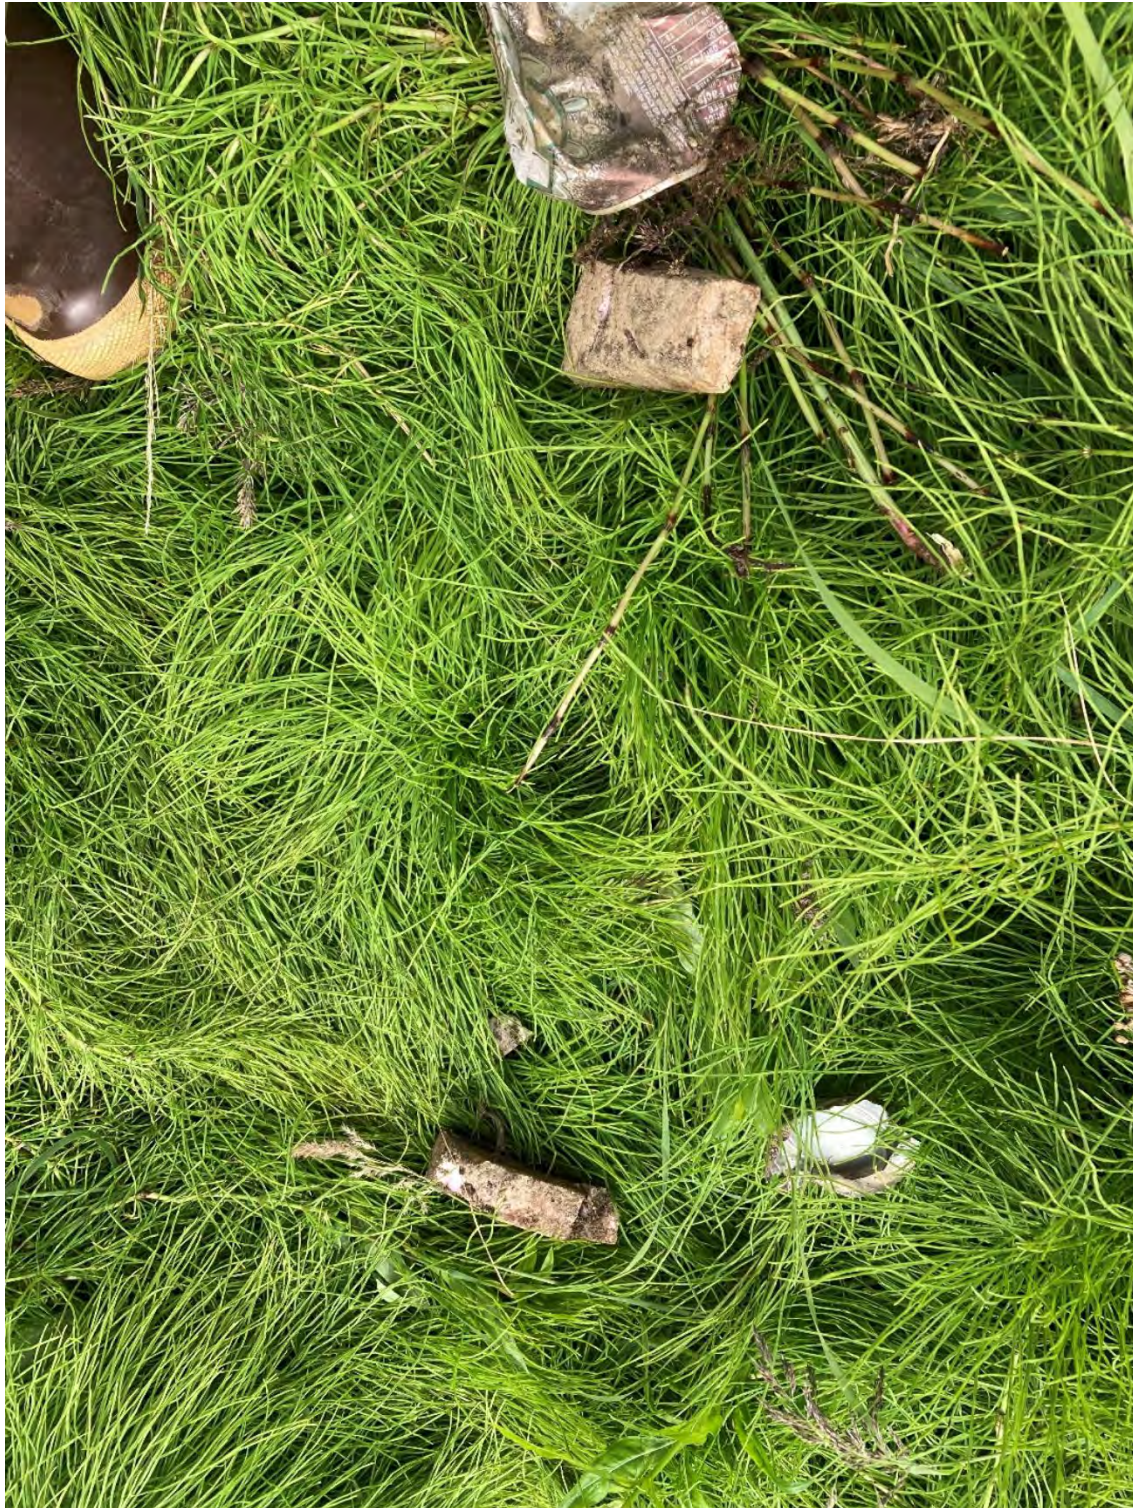
0718ELM37 – Buried foam and soda cans found at 2407ELIM-TANK06

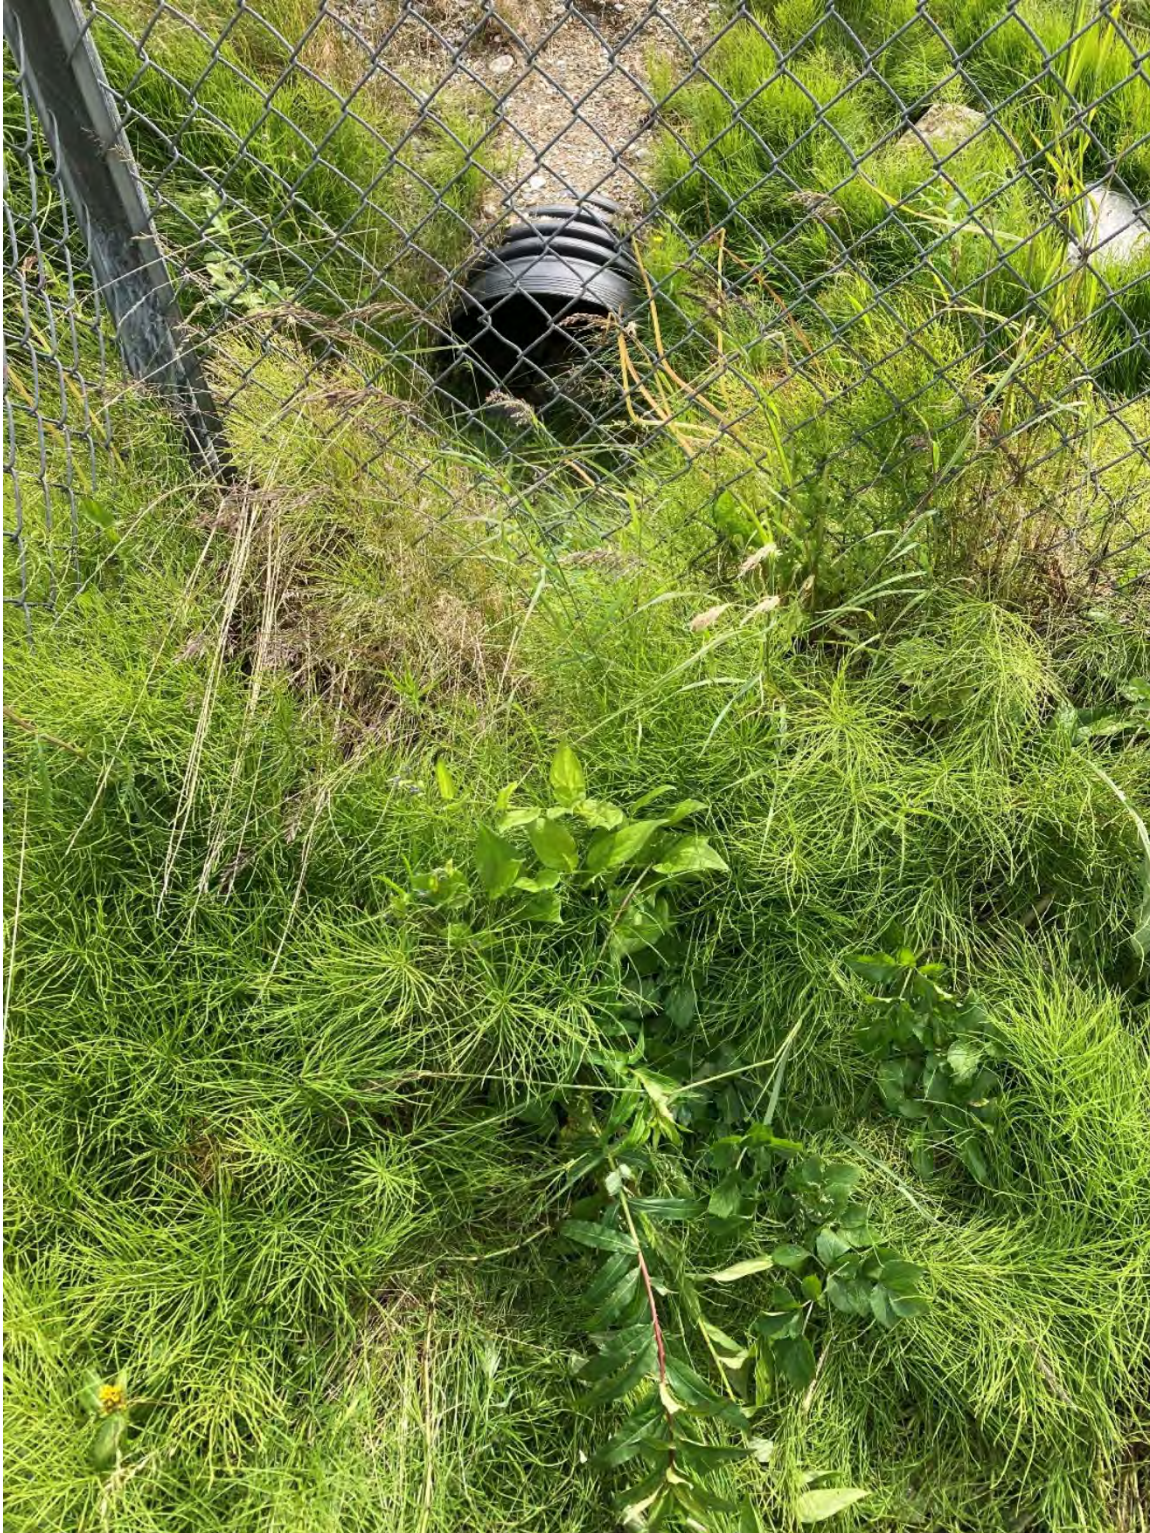
0718ELM38 – Suspected drainage pipe from within site boundaries, facing southeast
