CIAP WEAR Trip Report
Koyuk (population 342)
September 26, 2013 and August 12, 2014

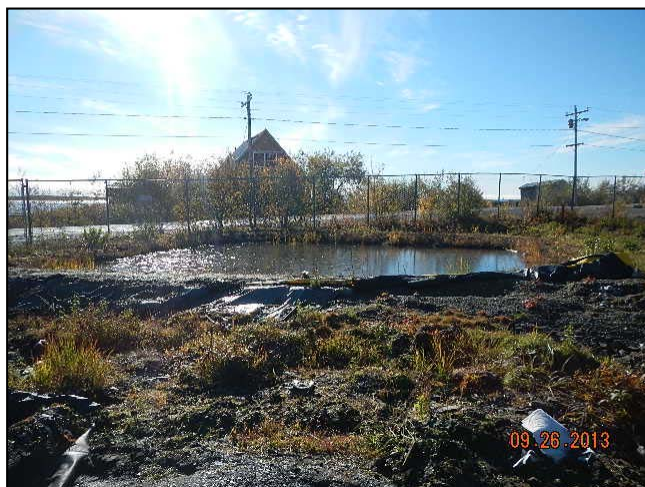
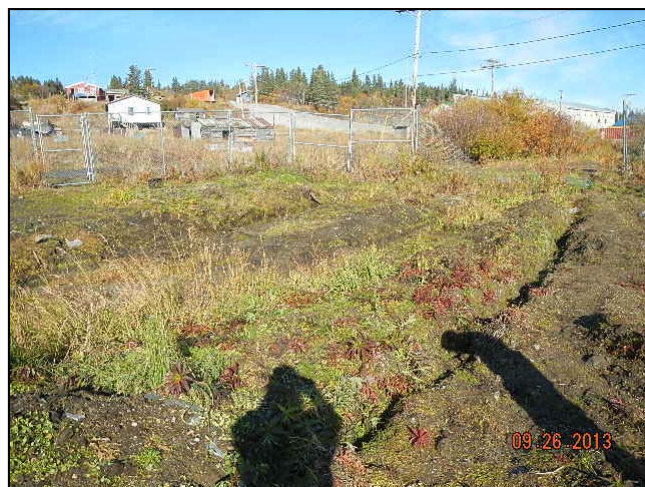
2013 Photos

- **Old AVEC Tank Farm, 64.931028/-161.159092 (Active)** – This former tank farm was operated by AVEC from around 1969 – 2005 until the construction of the new tank farm. It is an active Contaminated Site (File ID 610.57.001) due to petroleum contamination. The tanks and other associated buildings were removed from the site in 2012, and a Phase I Assessment was completed in February 2013. As of this site visit, the site was fully fenced; however the fence had fallen down and was accessible from the adjacent preschool building. There was a large pond of water in the remaining liner, but it had dried up by the 2014 visit. No visible changes occurred between the visits except for heavier vegetation growth. It is located 270 feet from the Koyuk River.

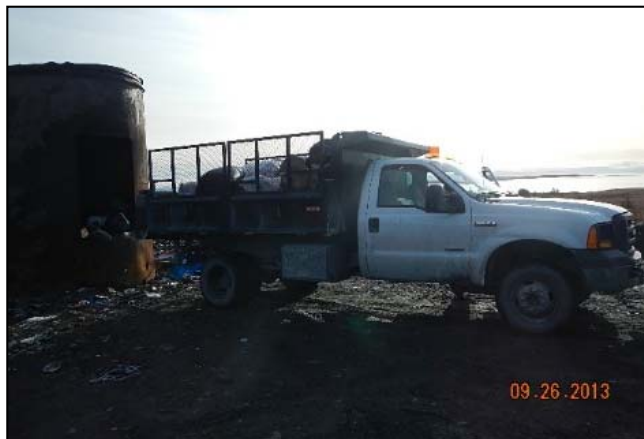
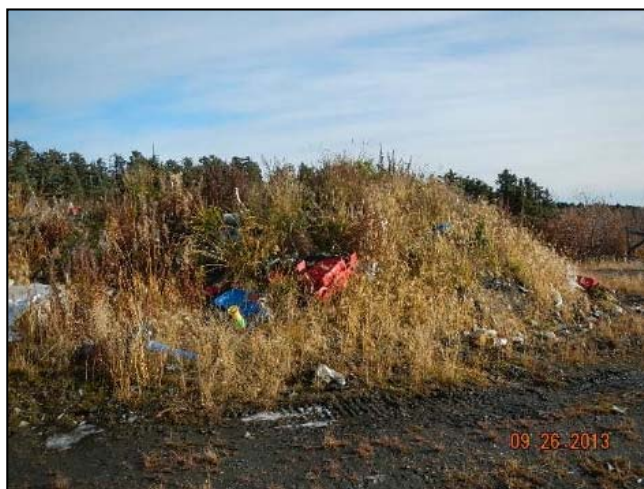
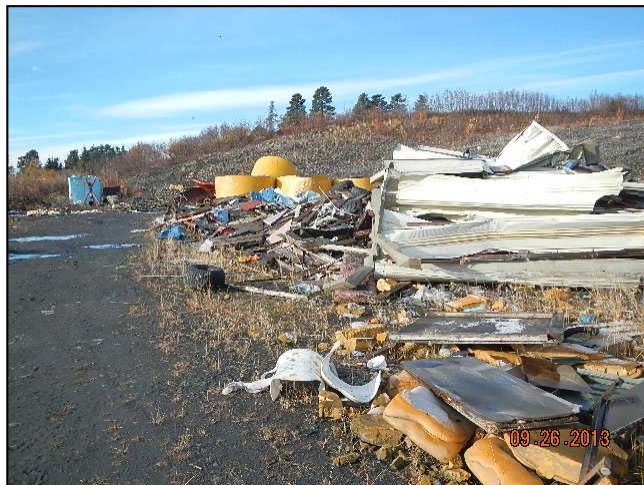
2013 Photos

- **Landfill, 64.929877/-161.188885 (Active)** – This Class III landfill was constructed around 1995 and is located more than half a mile east of the community along a maintained gravel road. It is operated by the City of Koyuk as an area fill landfill that accepts municipal waste and construction and demolition debris. A homemade burn unit is used by two part-time operators, who also run a waste collection program with a fee structure. Since the previous inspection in 2011, a large portion of the landfill was consolidated, compacted, and covered. This resolved the leachate problem that was created by water seeping through the exposed waste. A separate, large salvage area is located outside the landfill boundaries that contains metals, white goods, drums and various other materials. A large amount of construction and demolition debris from a housing improvement project was noted in the salvage area in the 2014 inspection. This site was permitted for the first time in 2014. The landfill is located 1,665 feet from the Koyuk River.

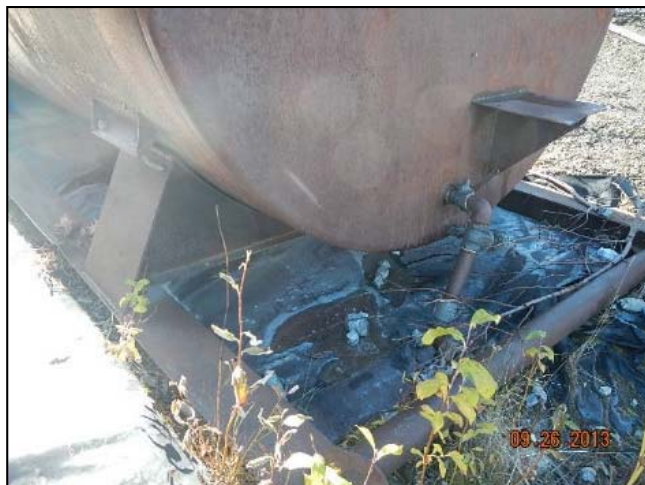
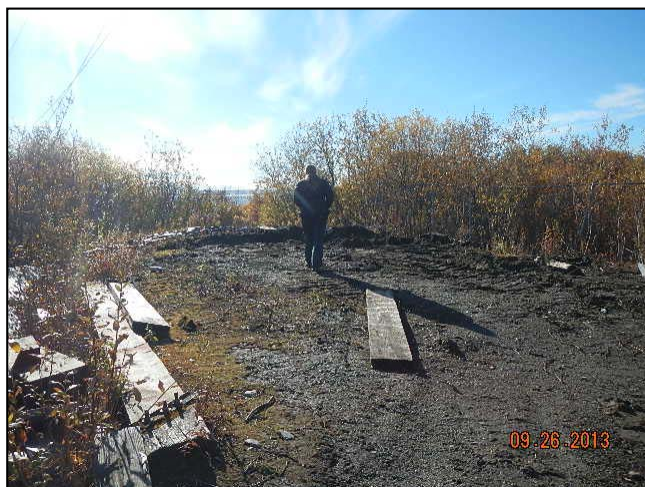
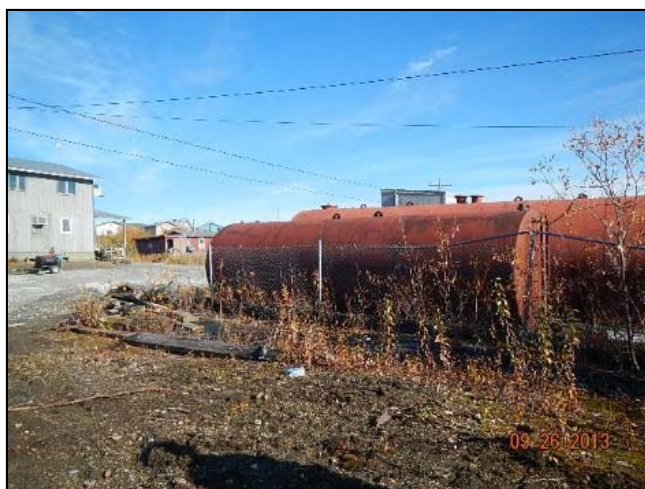
2013 Photos

- **Koyuk Native Corporation Tank Farm, 64.929930/-161.163340 (Active)** – This tank farm is owned by the Koyuk Native Corporation. It has not been in service since 2005 when the new consolidated tank farm was constructed. It is an active Contaminated Site (File ID 610.38.003) due to petroleum contamination. It consisted of three vertical tanks and two horizontal tanks. The three vertical tanks had been removed as of our visit, but the two horizontal tanks remained. The horizontal tanks were situated on black plastic directly on the ground and the plastic was torn in multiple places. This site remained unchanged between the 2013 and 2014 inspections. The site is located 250 feet from the Koyuk River.

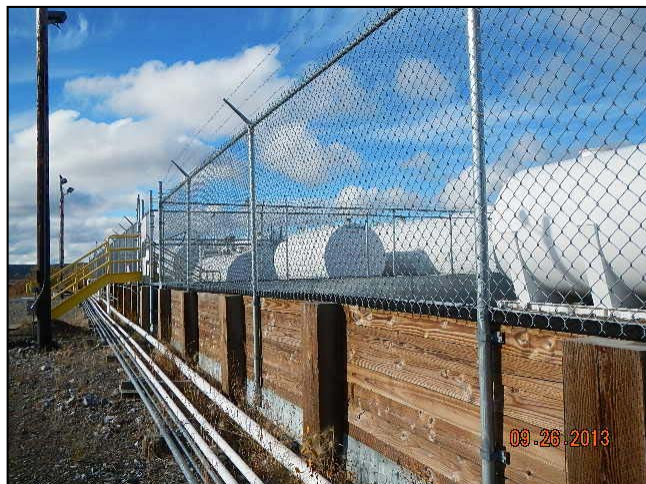
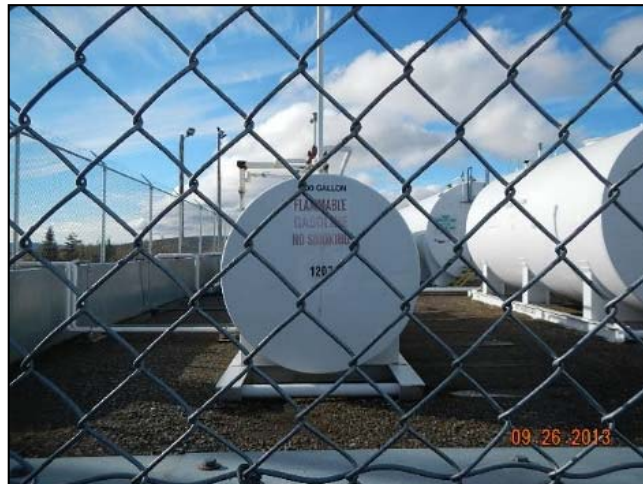
- **Tank Farm, 64.931867/-161.167939 (Active)** – This consolidated tank farm was constructed in 2005 through a Denali Commission project. It contains tanks for the City of Koyuk, AVEC, and the Bering Strait School District with the Koyuk Native Corporation as the operator. It contains a total of 18 fuel tanks with a total capacity of 83,700 gallons of gasoline and 213,400 gallons of diesel. The site consists of three separate lined wooden cells within a fully fenced and locked area. It is located in an elevated area above the community between the sewage lagoon and the power plant. The Koyuk River is approximately 990 feet south.

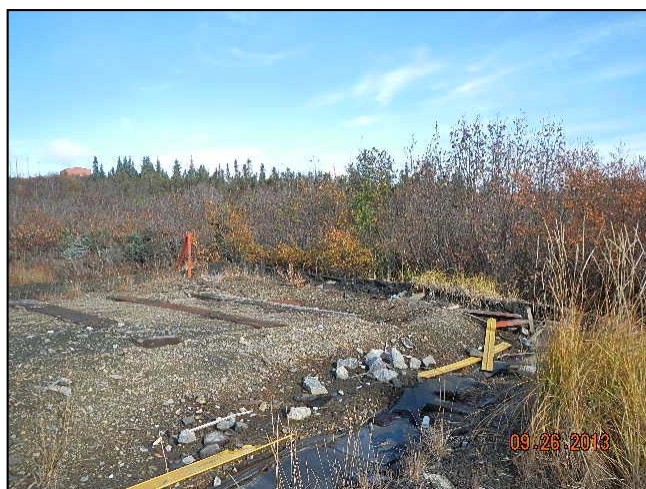
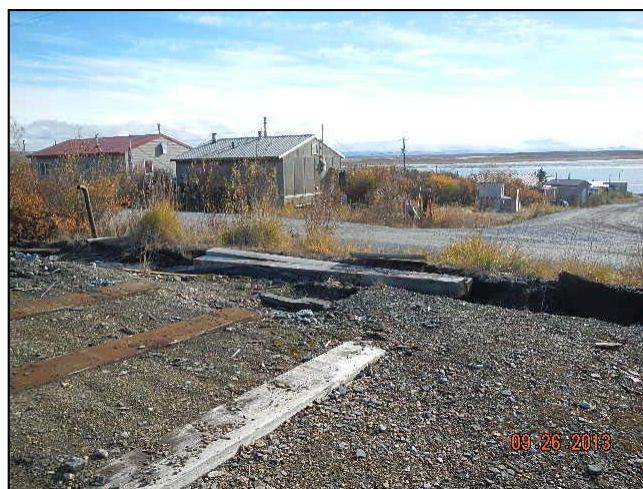
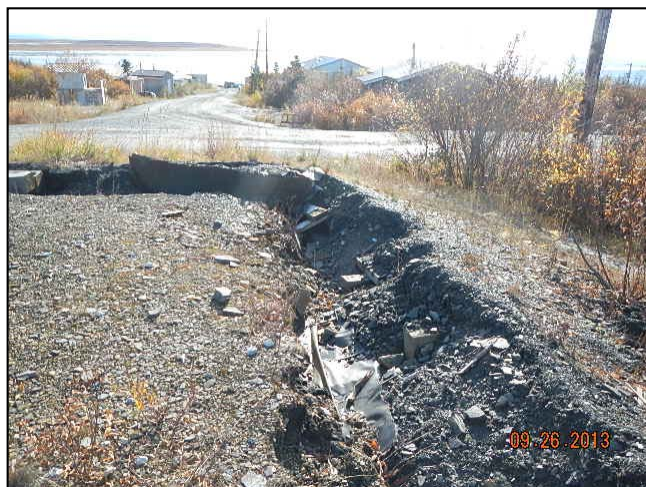
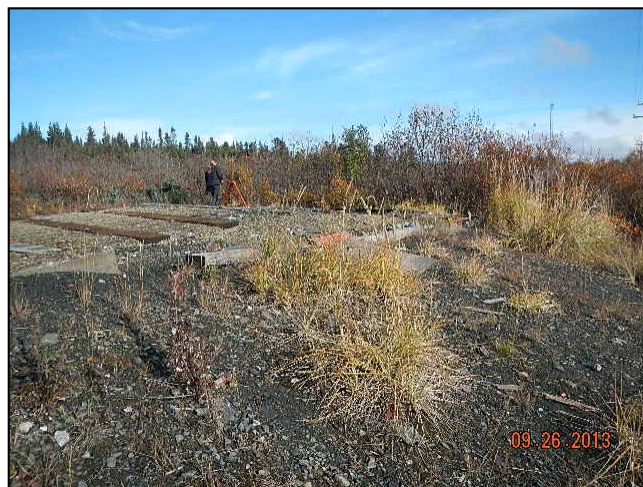
- **Old City Tank Farm, 64.931986/-161.164451 (Abandoned)** – This is the location of the former City of Koyuk tank farm. It contained two vertical fuel tanks within an earthen bermed area on the north end of the community. As of our visit, the tanks had been removed, but the plastic liner and wooden boards remained in place. It is 980 feet from the Koyuk River.

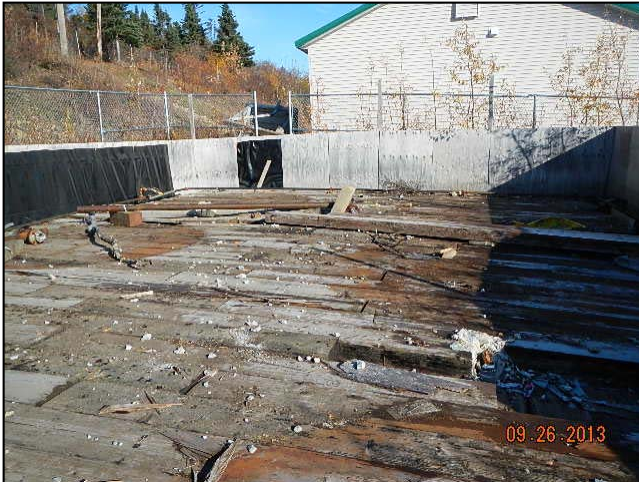
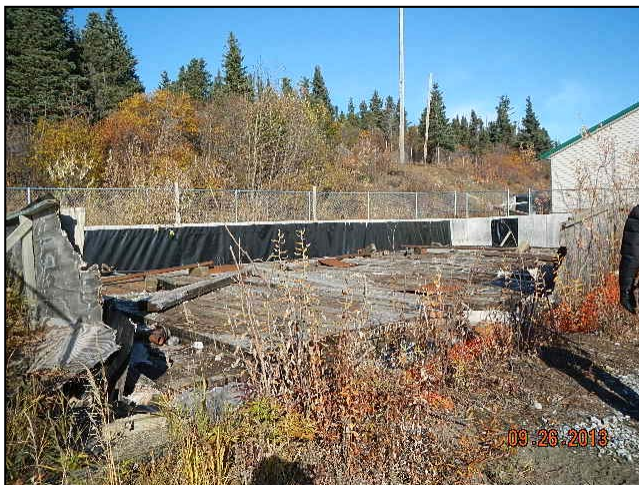
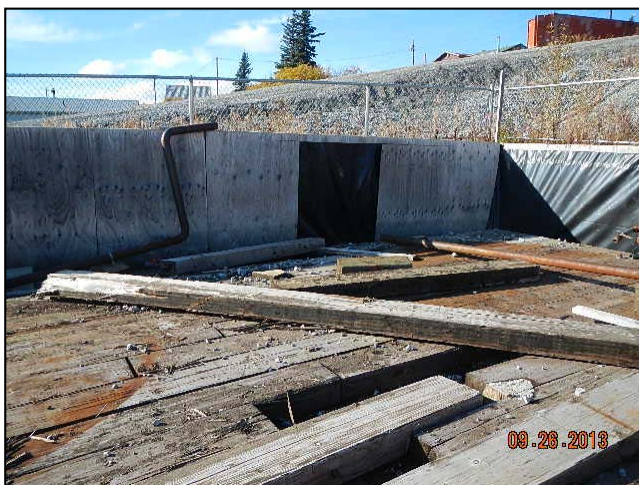
2013 Photos

- **School Old Tank Farm, 64.932104/-161.159016 (Abandoned)** – This tank farm was owned and operated by the Bering Strait School District. It originally consisted of eight vertical fuel tanks on a raised, lined wooden platform within a fenced area. The wooden platform consisted of boards more than 4 inches in height. At the time of the site visit, the tanks had been removed and some of the wooden platform had been pulled up. The area had such an extreme fuel odor that inspectors had to leave the area. This site also remained unchanged between inspections. A strong fuel odor was still present in the 2014 inspection with sheening in collected water. This site was reported to ADEC Prevention and Emergency Response Program. It is located 30 feet from teacher housing and 145 feet from the school. The Koyuk River is approximately 670 feet to the south.
