# Phase II ESA Report of Findings (Subsurface)

Elim City Shop  
Moses Point Road  
Elim, Alaska

Alaska DEC Contaminated Site ID 600.38.007  
Alaska DEC Hazard ID 25510

January 2025

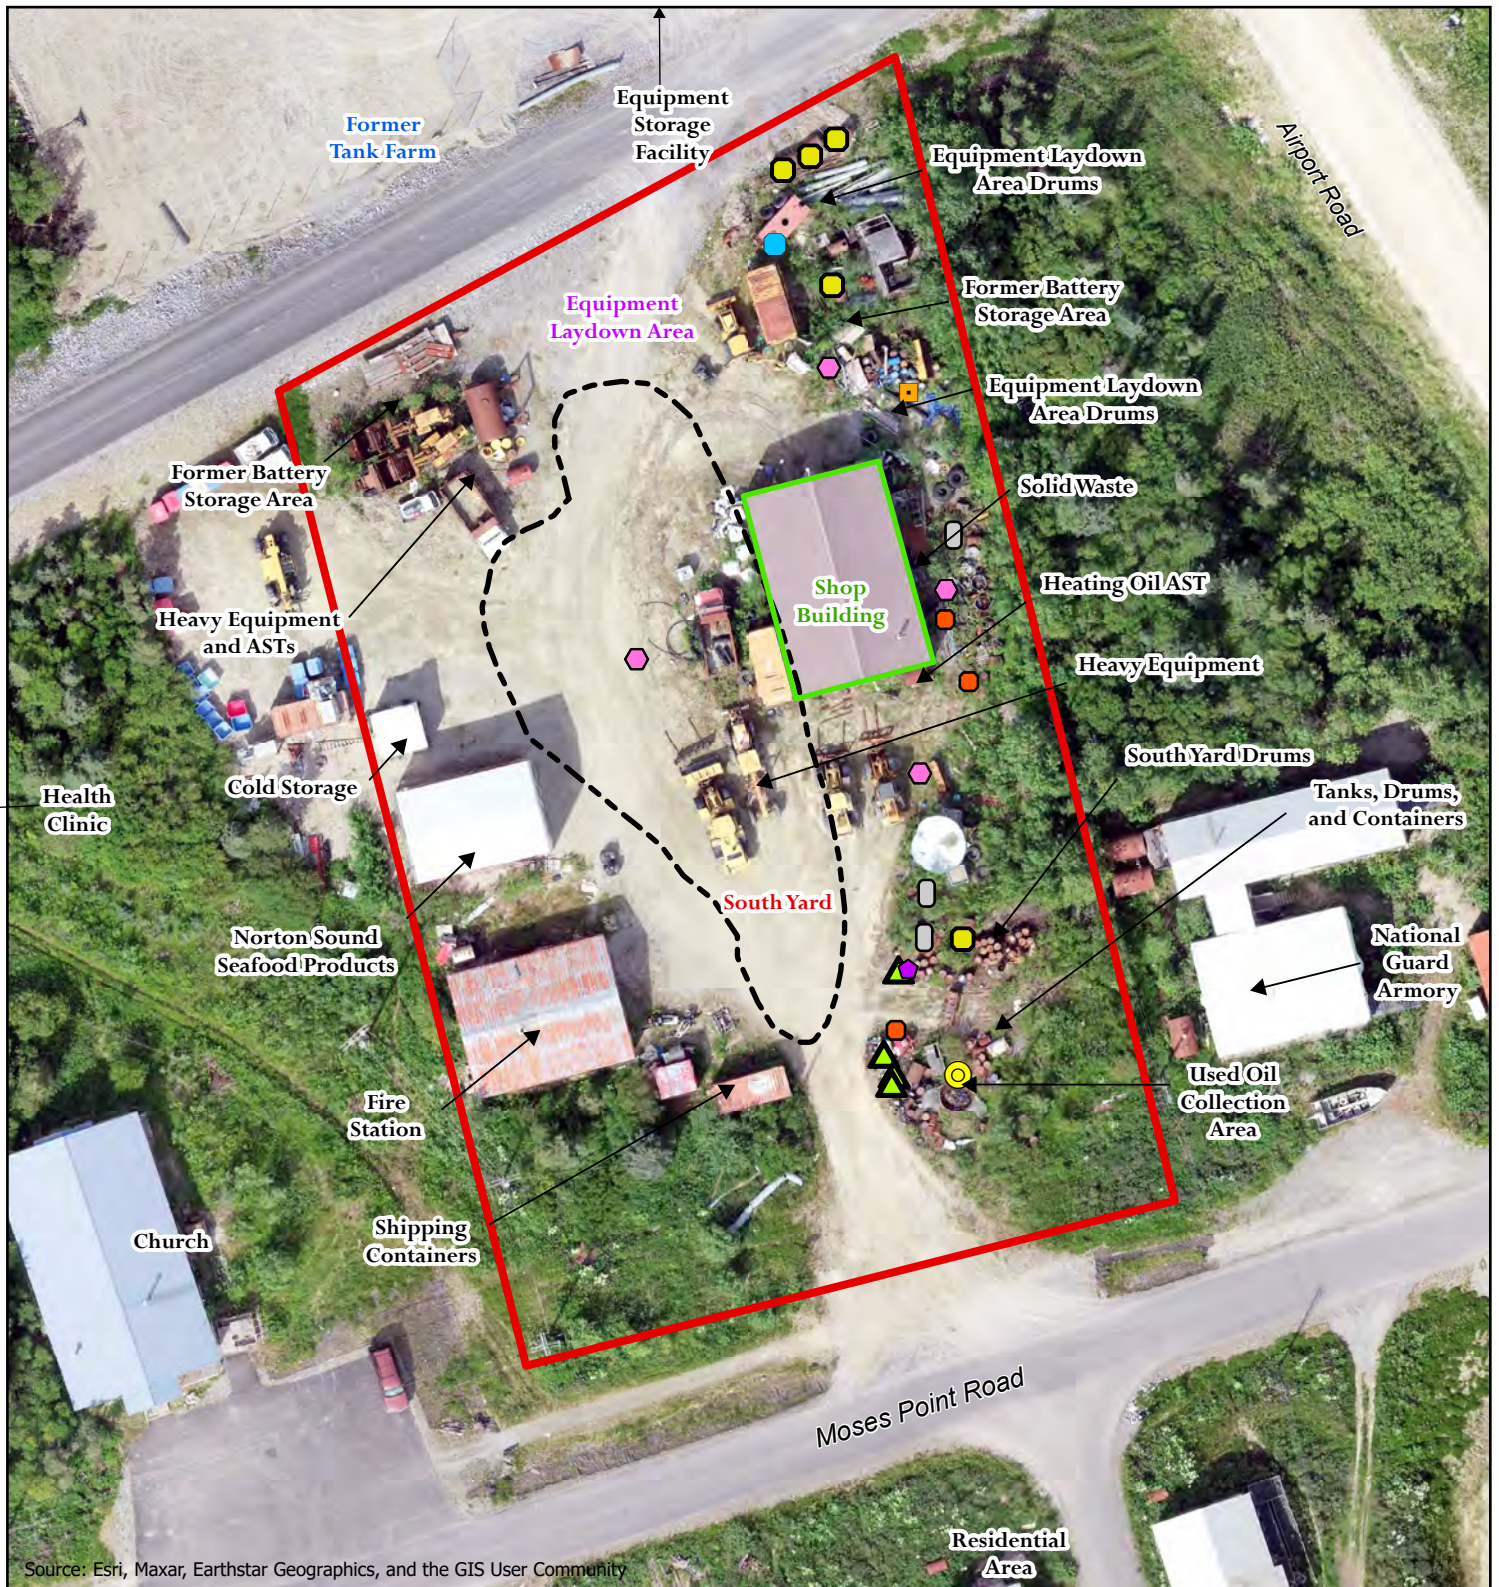
### Documented Surface Wastes Elim City Shop Elim, AK Figure 4c

- ◆ Engine or engines
- Frack Fluid Tank
- Gasoline Container
- Generator
- Glycol Odor and Soil Staining

- ▲ Intermediate Bulk Container
- Propane Tank
- ◆ Soil staining observed
- UST

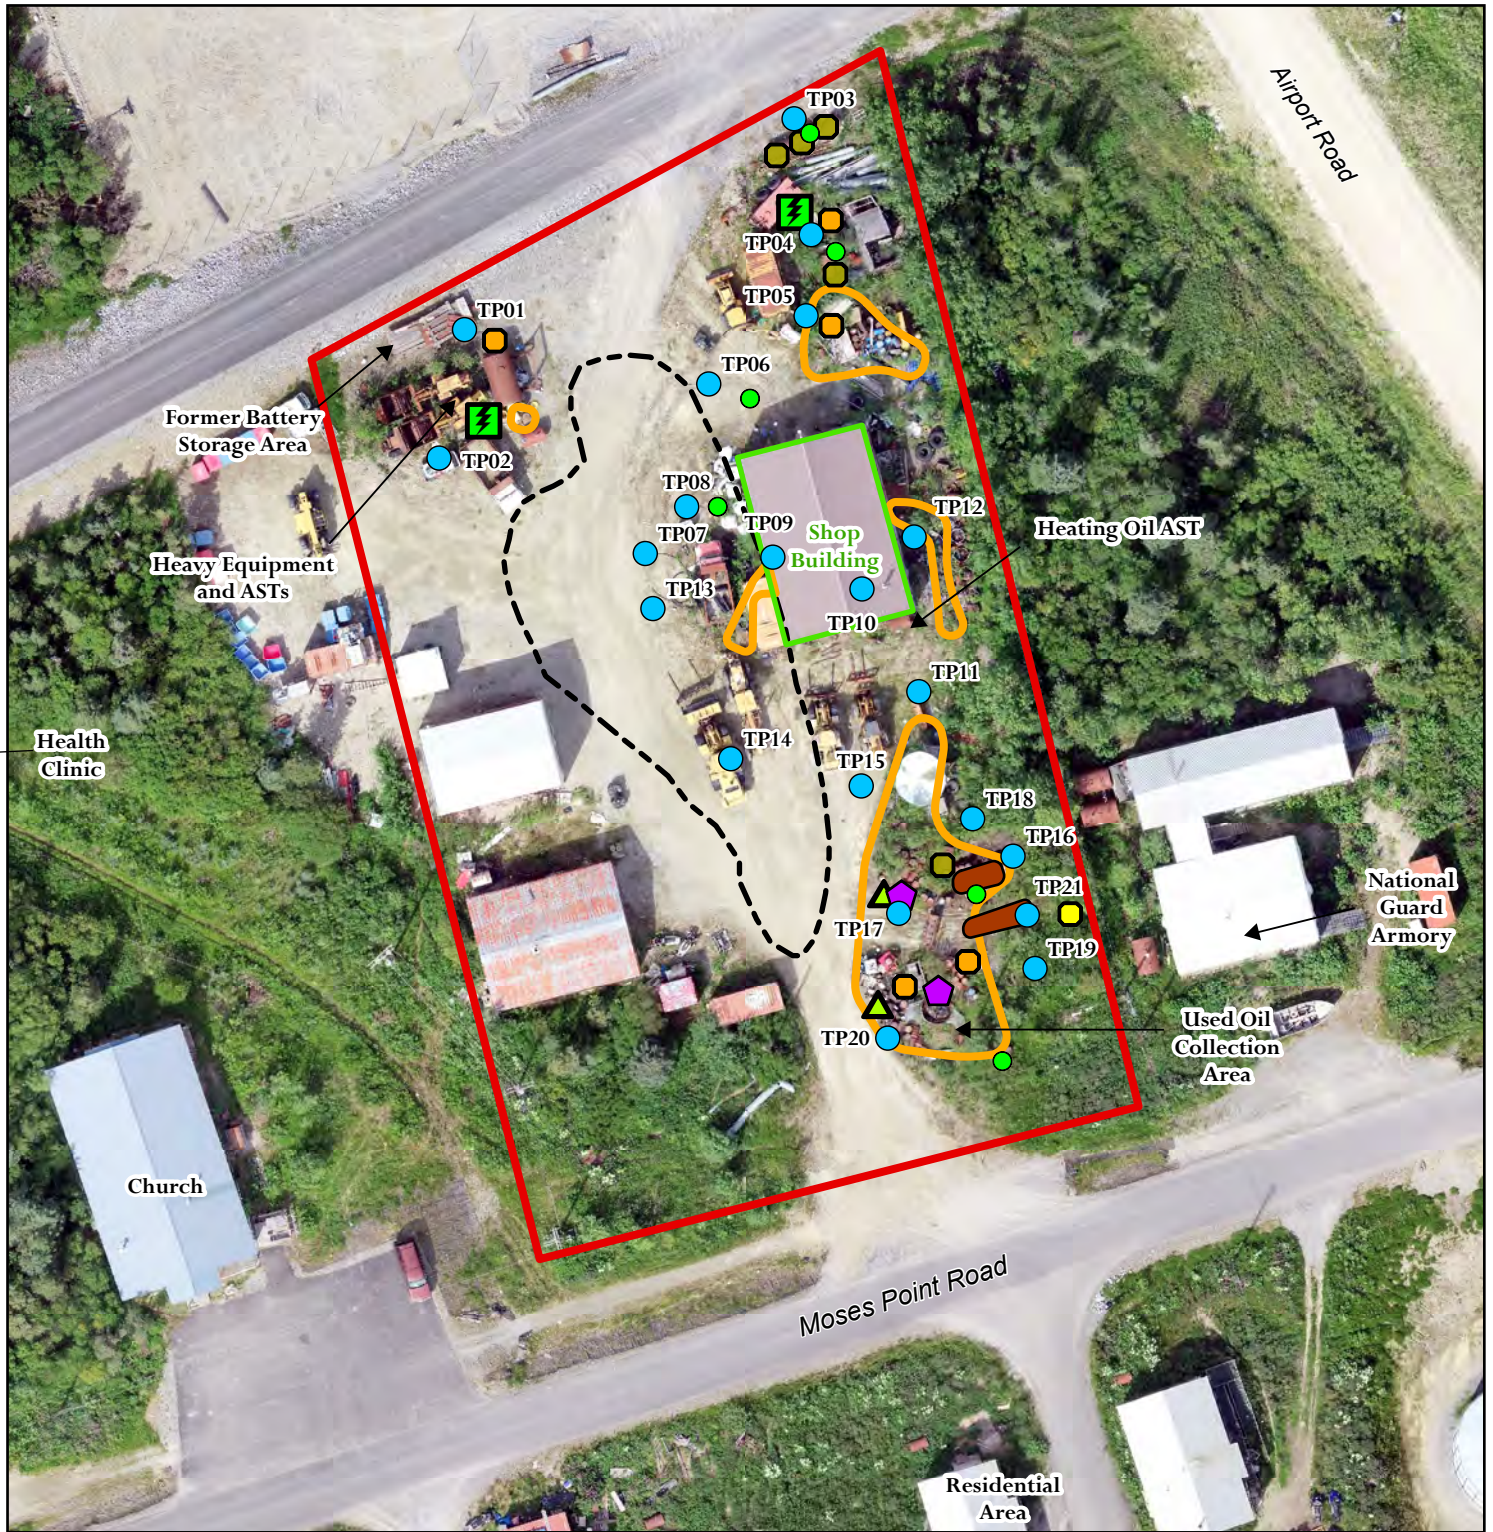
**Sampling Locations**  
**Elim City Shop**  
**Elim, AK**  
**Figure 5**

Test pit locations were selected to target the following site features and conditions:

- Used oil collection area;
- Soil within two areas surrounded by berms;
- Battery storage areas and ASTs;
- Areas containing drums;
- Exterior areas of stained soil;

- Intermediate bulk containers and former USTs;
- The location of two former 10,000-gallon ASTs;
- Several locations that exhibited elevated PID readings (Oasis 2010);
- Interior areas of stained soil; and
- The southeastern property boundary adjacent to the Army National Guard ASTs.
