ELIM OLD AVEC TANK FARM ABBREVIATED PRELIMINARY ASSESSMENT

This Abbreviated Preliminary Assessment (APA) for the Elim Old AVEC Tank Farm in Elim, Alaska was conducted by the Alaska Department of Environmental Conservation (ADEC) Contaminated Sites Program (CSP) under the ANCSA site verification program.

Site Name: Elim Old AVEC Tank Farm

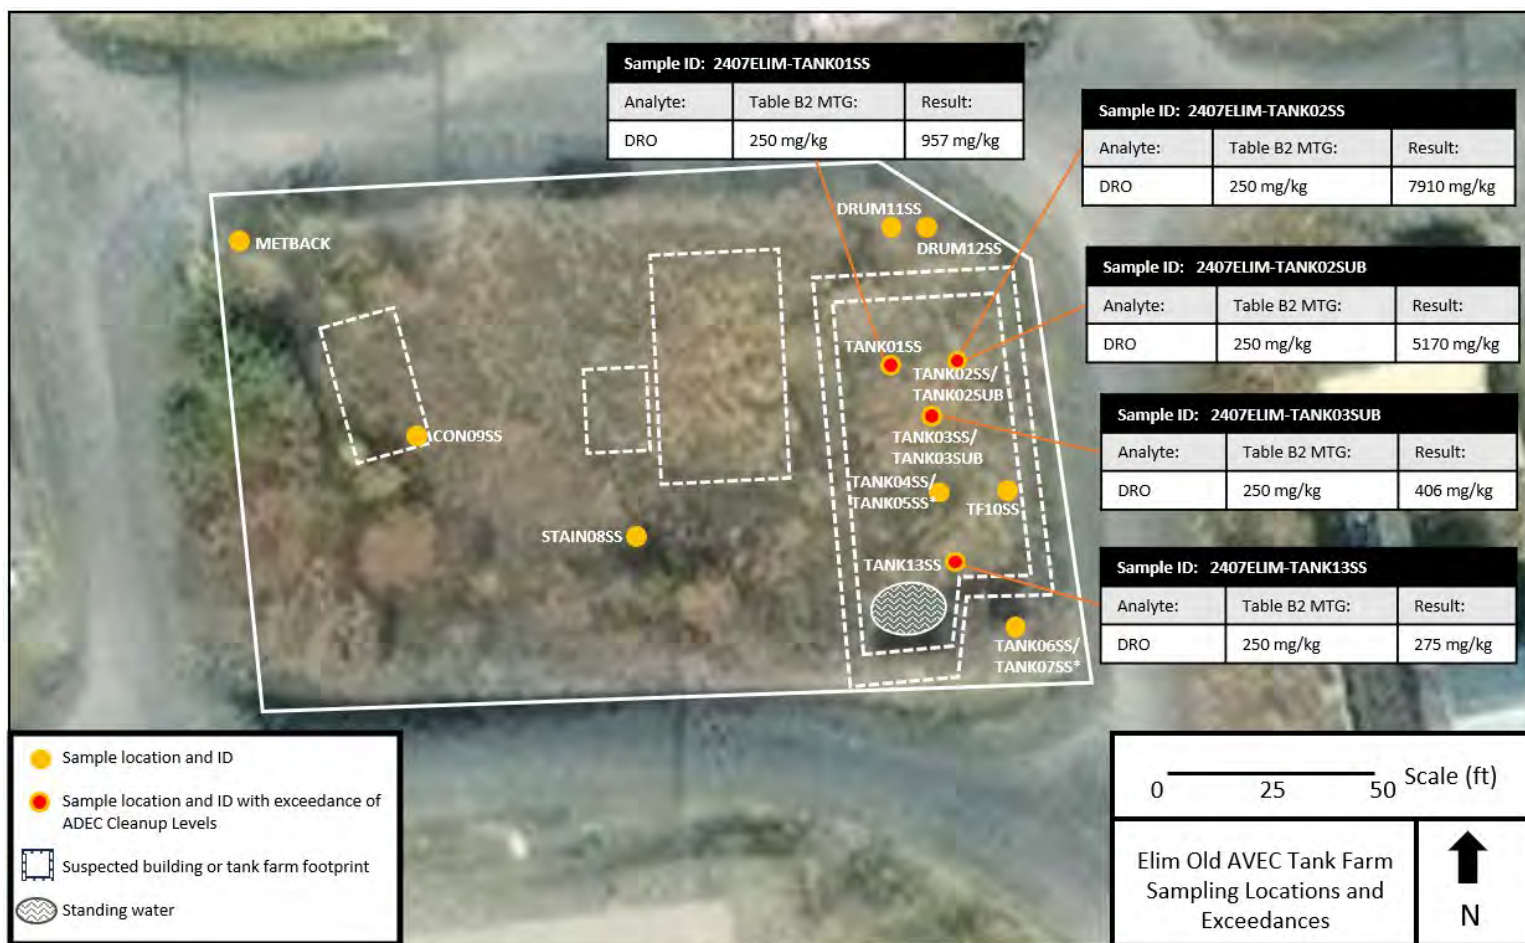
Figure 3 Elim Old AVEC Tank Farm sampling locations and exceedances.

Five samples exceeded the most stringent CUL. Samples 2407ELIM-TANK01SS (6" bgs), 2407ELIM-TANK02SS (9" bgs), 2407ELIM-TANK02SUB (14" bgs), and 2407ELIM-TANK03SUB (17" bgs), were collected in the upper portion of the tank farm, where historic contamination was suspected to have occurred. Each sample exceeds DRO CUL at 957mg/kg, 7,910 mg/kg, 5170 mg/kg, and 406 mg/kg, respectively. 2407ELIM-TANK13SS collected at 6" bgs in the lower portion of the tank farm exceeded DRO CUL at 275 mg/kg. Low-level detections of COPCs were found in other samples, but none exceeded applicable CULs.

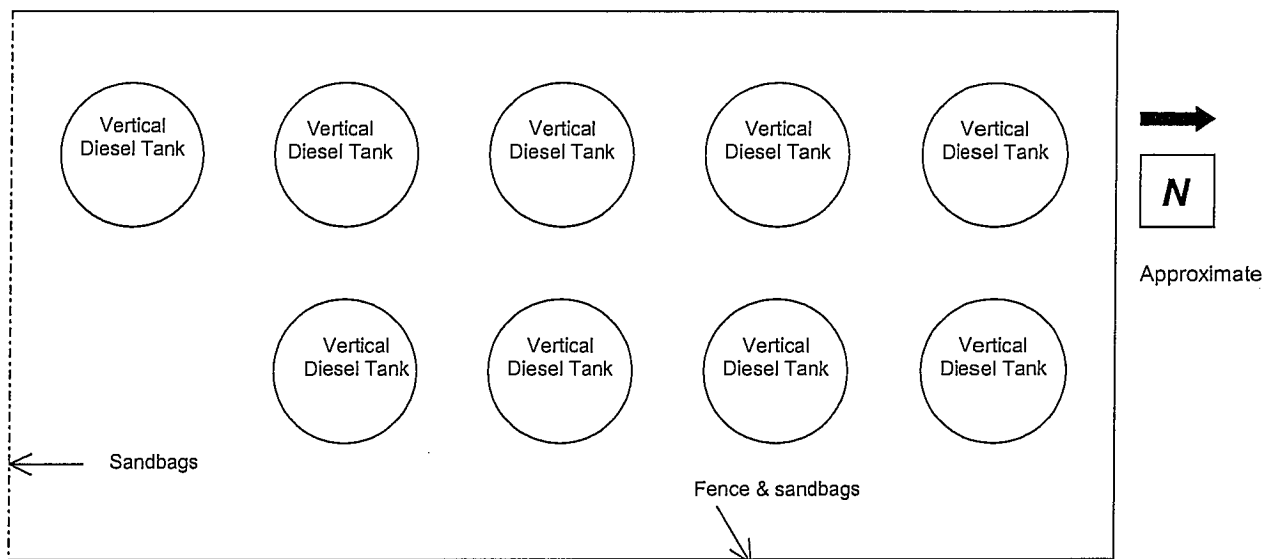
Figure 3-2 Layout of the Alaska Village Electric Cooperative (AVEC) Tank Farm

The tank farm is surrounded by fencing, and contains several 55-gallon fuel drums and other smaller containers. The fuel tanks appeared to be in good condition, with the southern tanks being in the best condition. The surface of the northern tanks showed signs of rust. The tanks rested on wooden platforms. The wooden platforms and sand bags appeared to be in good condition. No liner was observed. Vegetation was noted surrounding the fenced area. Figure 3-2 shows the relative position of the various tanks.

Soil Sample Collection. Soil sample ELM-S-002 was screened with a PID and submitted for laboratory and PetroFlag analysis. The sample was collected at approximately 2 feet bgs, on the east side of the tank farm, approximately 30 feet north of its southeast corner and approximately 3 feet east of the fence. The soil was a sandy gravel-like material and included a slate-like shale material. As indicated in Table 3-4, the soil had a relatively low reading from the PID meter, and contained a relatively low concentration of DRO.

According to the site conceptual model shown in Figure 3-1 and results of analysis, it is apparent that any petroleum contamination from the site would be limited to the soils immediately beneath the tank farm. When the tank farm is decommissioned, additional sampling should be conducted to determine whether any contamination is present beneath the tank farm. While the AVEC Tank Farm is in operation, no additional site investigation is recommended. Table 3-5 summarizes the rationale for any additional sampling for the site.

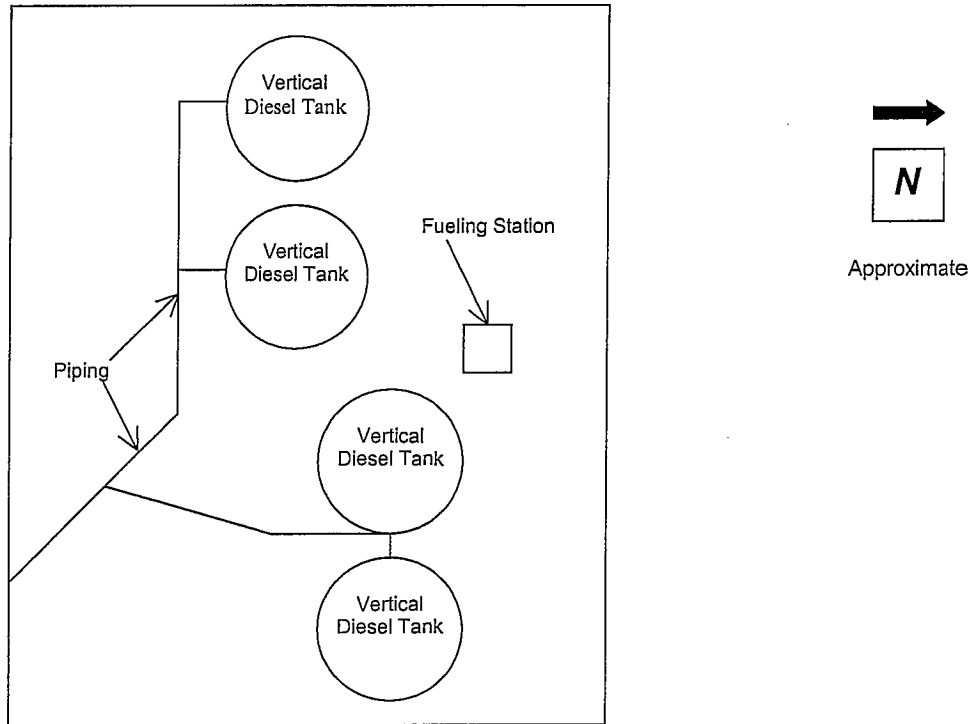
Figure 3-3 Layout of the City of Elim Tank Farm

Sample ELM-S-005 was collected approximately 5 feet east of the bermed area and south of the fueling station, at a location where the surface material had the same appearance as the nearby road. The soil was highly compacted, consistent with that of the road material. Because an odor was noted in the soil at various locations south of the bermed area, additional samples were collected and subsequently analyzed at an analytical laboratory and with

PetroFlag kits. As the sampling progressed, it became evident through the level of the odor that the odor probably originated from the fueling station, not the tank farm tanks. Sample ELM-S-005a was taken 20 feet east of the berm and east of the fuel station. Sample ELM-S-005b was taken approximately midway between the north and south ends of the east berm, and approximately 3 feet from the east berm. Sample ELM-S-005c was collected 40 feet from the east side of the berm, and sample ELM-S-005d was taken approximately 50 feet from the east berm at a downgradient location east of the fueling station, where drainage flows directly to Elim Creek. Sample ELM-S-005e was collected near the southeast corner of the bermed area.

appearance of the soil around the fueling station that leaks have occurred at the fueling station. The extent of contamination is apparently limited to an area approximately 50 feet east of the fueling tank and in a plume probably less than 20 feet wide immediately in front of the fueling tank. The depth of contamination is not known.

Until the soil at the City of Elim Tank Farm can be further evaluated, it is recommended that, good housekeeping methods should be established and implemented to avoid further spills from operating the fueling tank. Table 3-7 summarizes the reasoning for any additional sampling at the site.
