PROPERTY ASSESSMENT AND CLEANUP PLAN

Old AVEC Tank Farm

Elim, Alaska

By:
SLR International Corp
April 2010

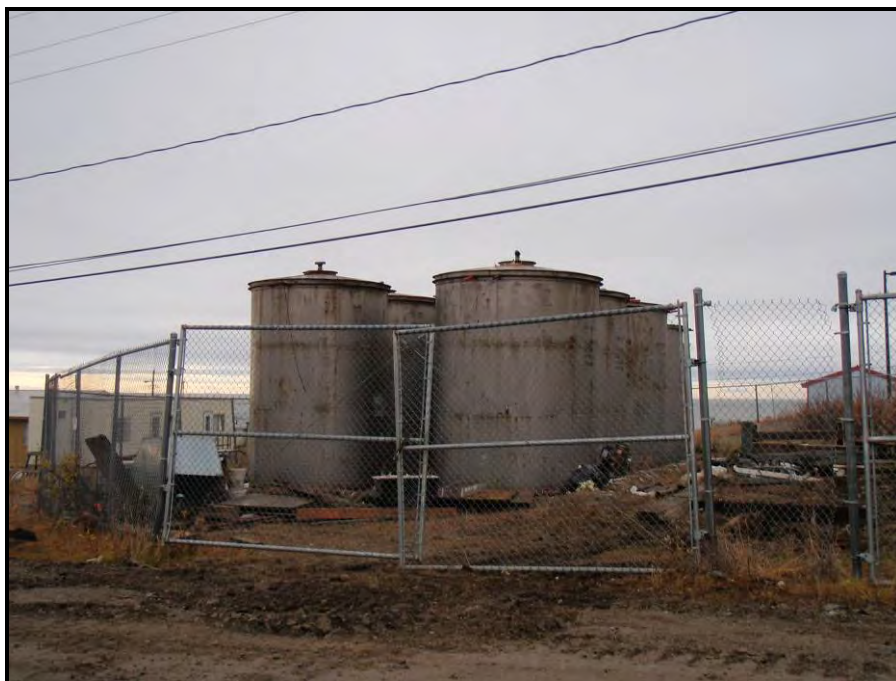
Photograph 1:

Vertical ASTs on the east side of the property (photograph taken looking south).

- Nine ASTs were observed on the Old AVEC Tank Farm property; the tanks are no longer in use and appeared to be empty. It is recommended that these tanks be decommissioned by a qualified contractor, cut up, and disposed of in the local landfill.

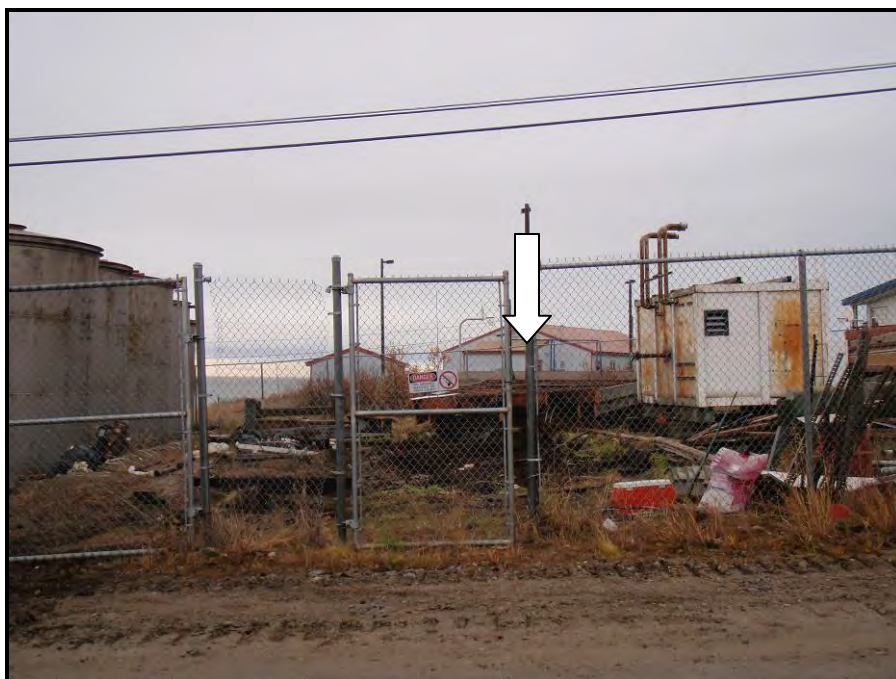
Photograph 2:

Central portion of the property; the floor of the former generator building found can be seen (beneath the arrow) and the white generator building is present on the right (photograph taken looking south).

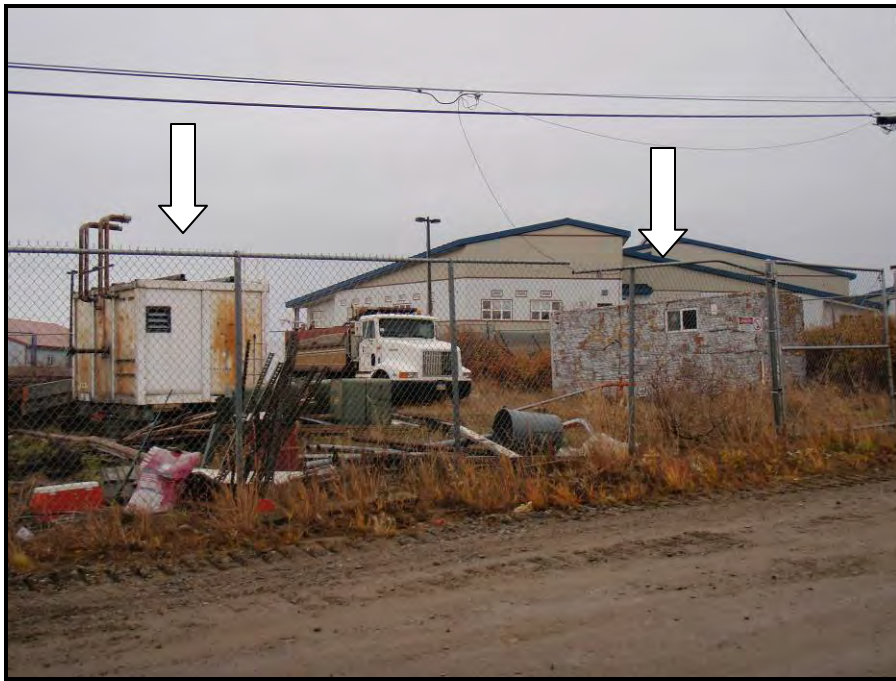
Photograph 3:

Western portion of the property. Both the white generator building (left) and the CONEX building (right) are visible as is the City of Elim's truck (photograph taken looking south).

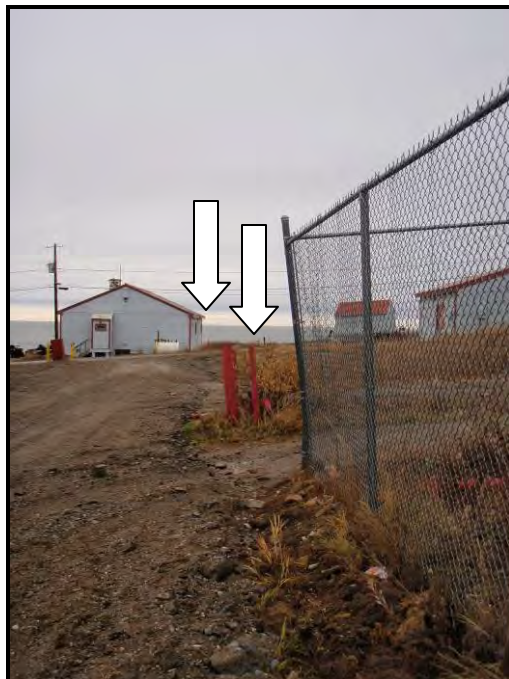
Photograph 4:

Piping headers associated with the Old AVEC Tank Farm fuel lines. A total of approximately 178 feet of buried piping is still present extending from the southeast corner of the tank farm.

- One hundred seventy eight feet of fuel line associated with the Old AVEC Tank Farm property was noted. The fuel line should be emptied of fuel and abandoned in place in compliance with state and federal regulations.

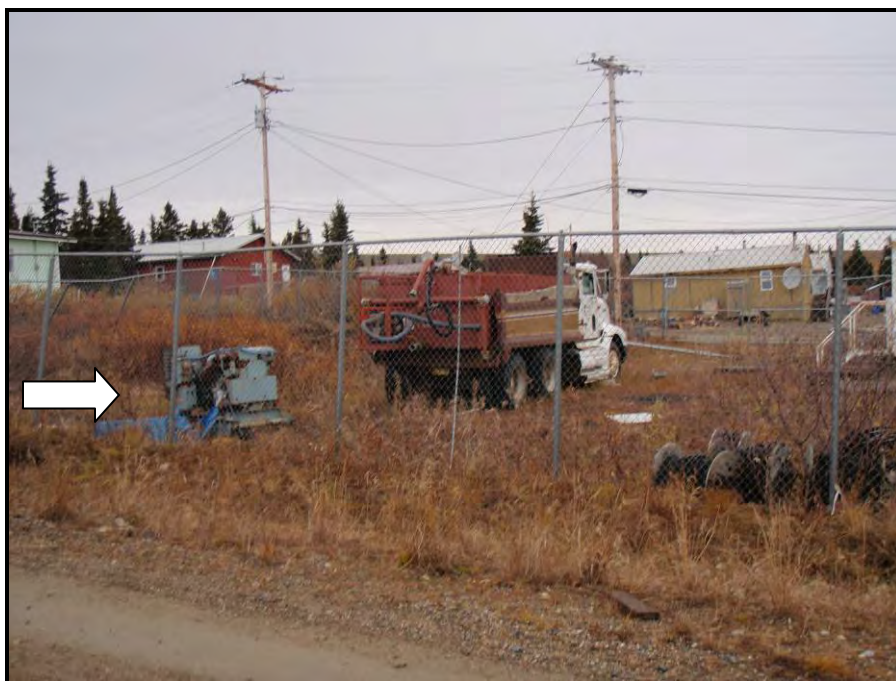
Photograph 5:
An old generator was present on the site.
No stained soil was observed next to this generator.

- A single generator is present within the fenced area on the property. It is recommended that the generator be reused within the community, if possible.

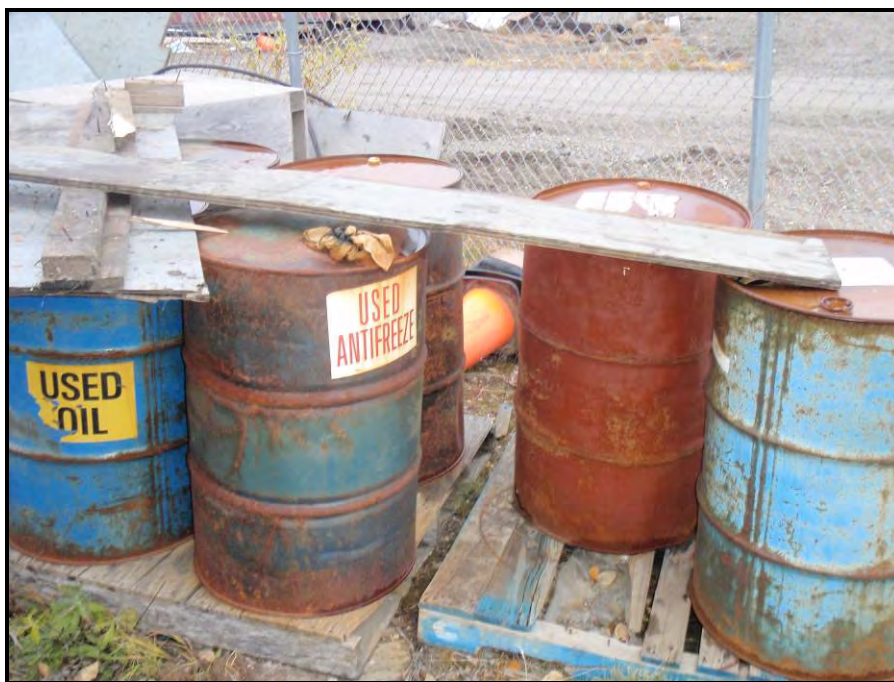
Photograph 6:
Drums located on the northeast corner of the Old AVEC Tank Farm.

- Seven 55-gallon barrels were located on the northeast corner of the Old AVEC Tank Farm property. Drums, if they contain fluid, should be sampled and disposed of according to all applicable state, federal, and local regulations. If possible, the drums can be reused within the community. It is recommended that if the drums contain used oil, the used oil be combusted in a waste oil burner for energy recovery. The waste oil would require testing to determine if it complies with state and federal regulations for this purpose, for example to check for the presence of chlorinated hydrocarbons. According to the City of Elim, there is a functional used oil burner at the City Shop. One drum of used antifreeze was noted during the 2009 site visit; used antifreeze will need to be shipped offsite for proper disposal.

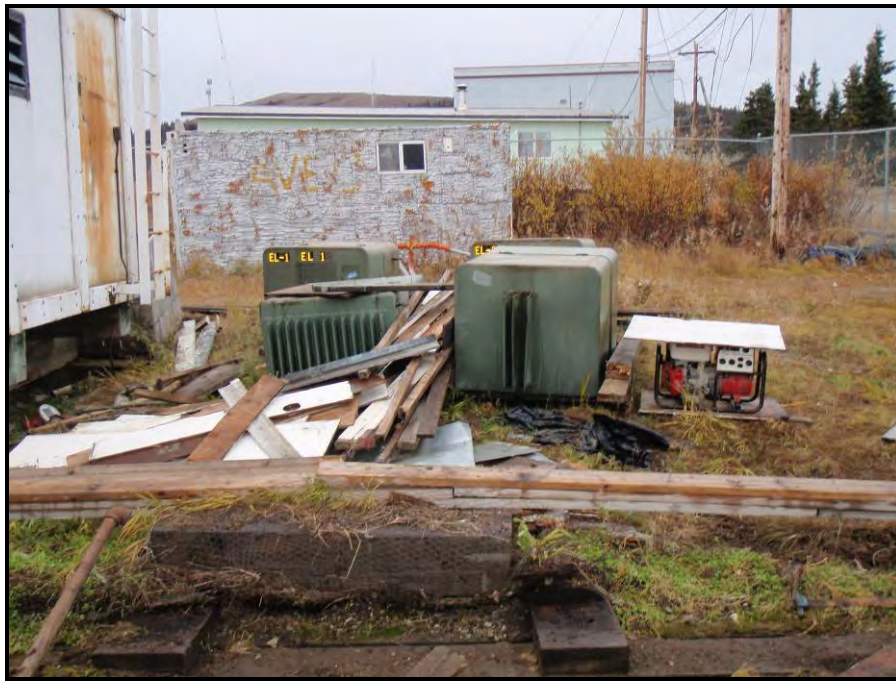
Photograph 7:

Old electrical boxes. The wood and generator in the foreground will be removed by Mr. Gary Nakarak who owns the former AVEC building.

- Four electrical boxes and other electrical equipment were noted on the property. Operational equipment should be reused within the community; non-operational equipment should be disposed of in the local landfill, if it does not contain PCBs or other hazardous substances.

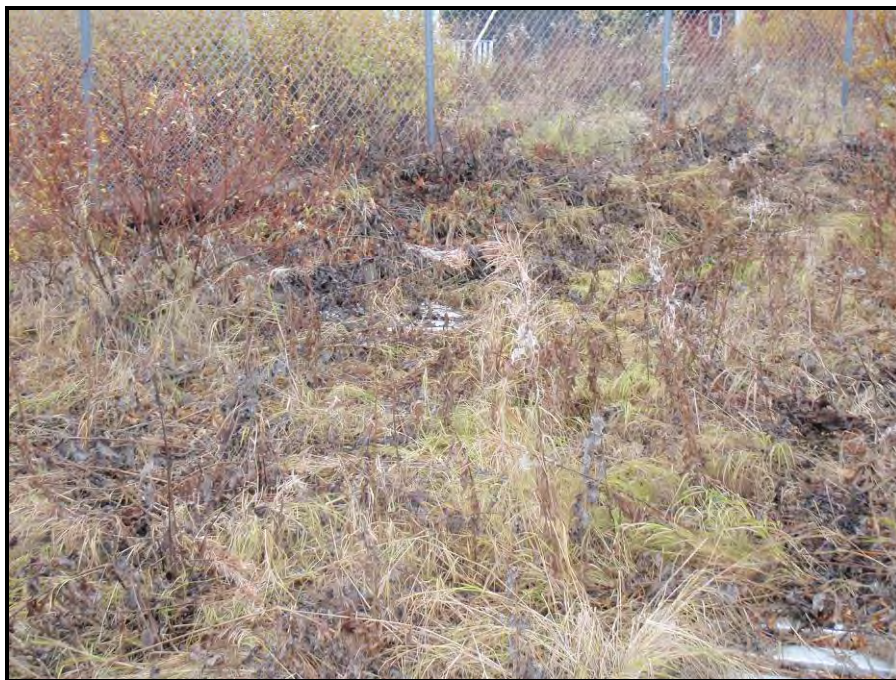
Photograph 8:

Stressed vegetation was noted in several locations on the site. It was unable to be determined if stressed vegetation is a result of site-related activities or due to runoff at the site.

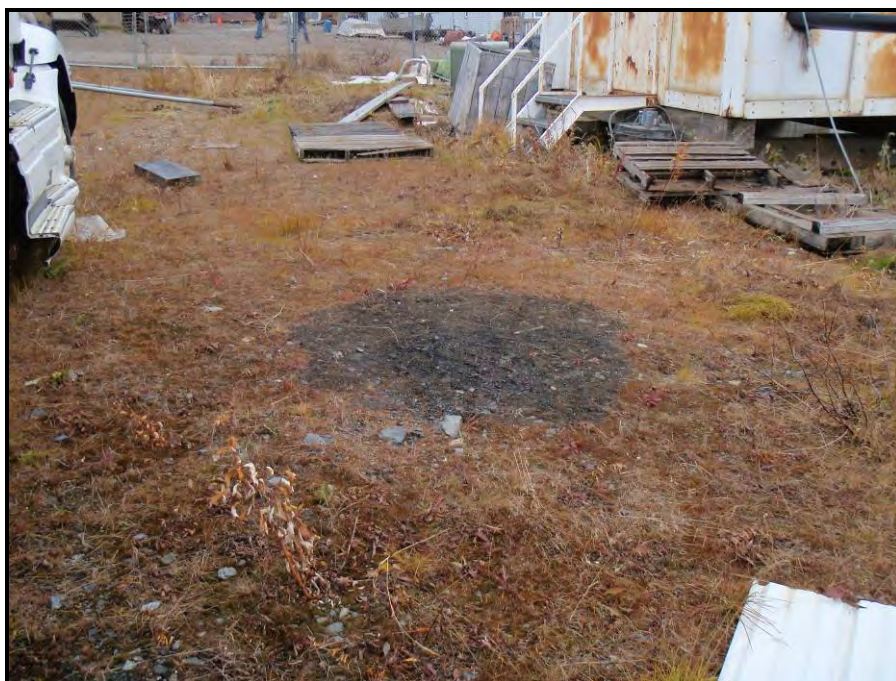
Photograph 9:

During SLR's 2009 Site visit (Section 4) it was observed that all nine ASTs were located within a lined containment area. Some corrosion was evident on the tanks, but all appeared to be empty. The 55-gallon drums and buckets were sitting on pallets outside of the lined area (Figure 3, Photograph 6 in Appendix C). One area of stained soil approximately 3 feet wide by 4 feet in length was observed.

Stained soil southwest of the white generator building; this was the only area where stained soil was observed.

One area of stained soil was noted on the Old AVEC Tank Farm property (Photograph 9) during SLR's site visit in 2009. The area is approximately 3 feet by 4 feet and the depth of contamination is unknown. No other areas of stained soil were observed, however a review of aerial photographs indicated that the ASTs have not always been inside a lined and diked containment and the potential exists for impacted soils beneath the ASTs.

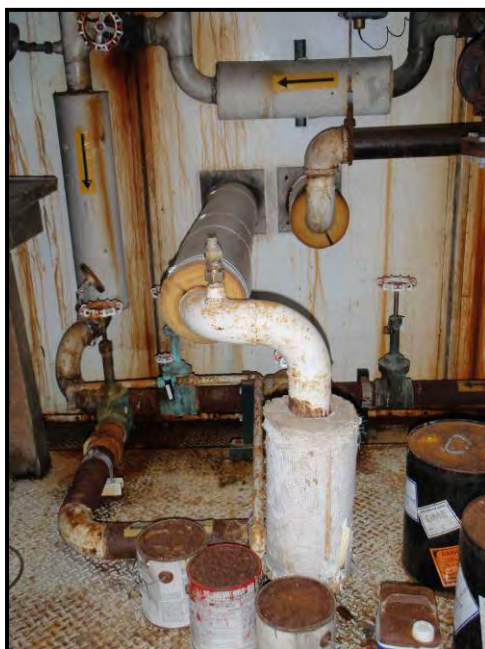
Photograph 10:

Piping and paint and paint thinner cans inside of white generator building.

In order to prepare the Old AVEC Tank Farm site for its proposed future reuse, the equipment and debris at the Site will need to be removed. It is recommended that electrical equipment, used oil, De-Solv-It, paint, and paint thinner be reused within the community if possible. In order to confirm or deny the presence of potential contaminants, which require special handling (i.e., PCBs, chlorinated solvents, and metals) and limit the removal of more soil than necessary, a targeted surface and subsurface soil investigation should be conducted during the solid waste removal phase of the cleanup. In addition, the targeted soil investigation should include sampling along the buried fuel line to investigate for potential leaks. Potential petroleum hydrocarbon contamination at the Site can best be managed through excavation and the remedial option of landfarming followed by use as landfill cover with approval from the DEC's Contaminated Sites Program and Solid Waste Program. To assure the project timeline, this approach should be executed using equipment, operators, and labor located within the Village of Elim and consultant assistance with reporting and project scoping. Waste management, excavation, and landfarm preparation can be implemented in one field season. It is estimated that three successive field seasons of landfarm fertilizer application, tilling, and sampling will be required to meet closure standards established by the DEC. The preliminary cost estimate for this work is \$271,395 (Appendix G). It should be noted that, because contaminant characterization work has not been completed, the cost associated with managing soils in this general cost estimate is for an assumed 100-cy unit volume of petroleum contaminated soil, and it is also assumed that no PCB-, RCRA metal-, or chlorinated solvent-impacted soil is encountered. Excavation and treatment of larger volumes of contaminated soils will result in lower per-yard, or per-ton, costs for the landfarming element. The project will rely on consultant assistance for documentation and reporting to DEC.

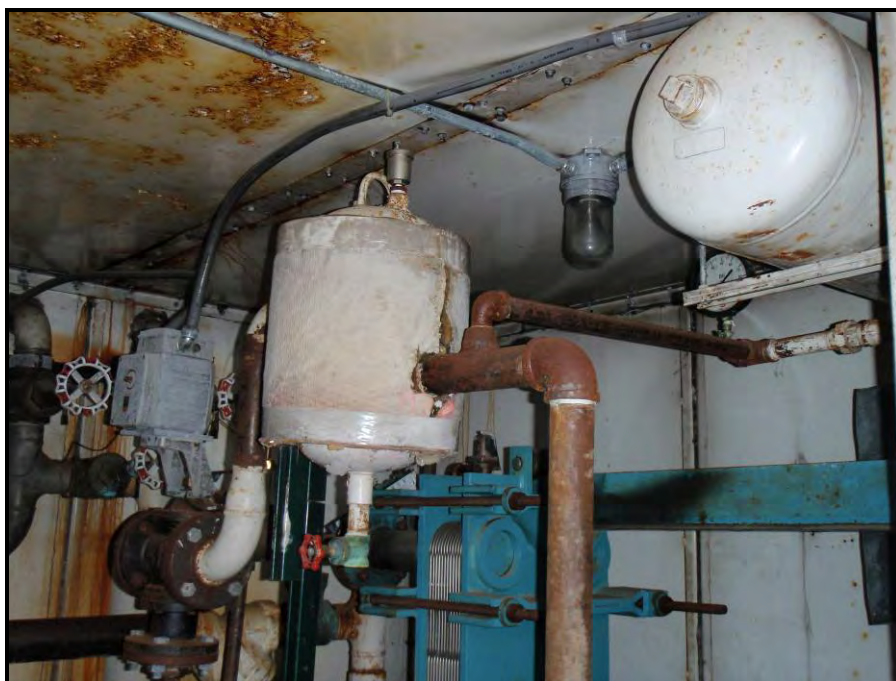
Photograph 11:
Equipment remaining inside the white generator building.

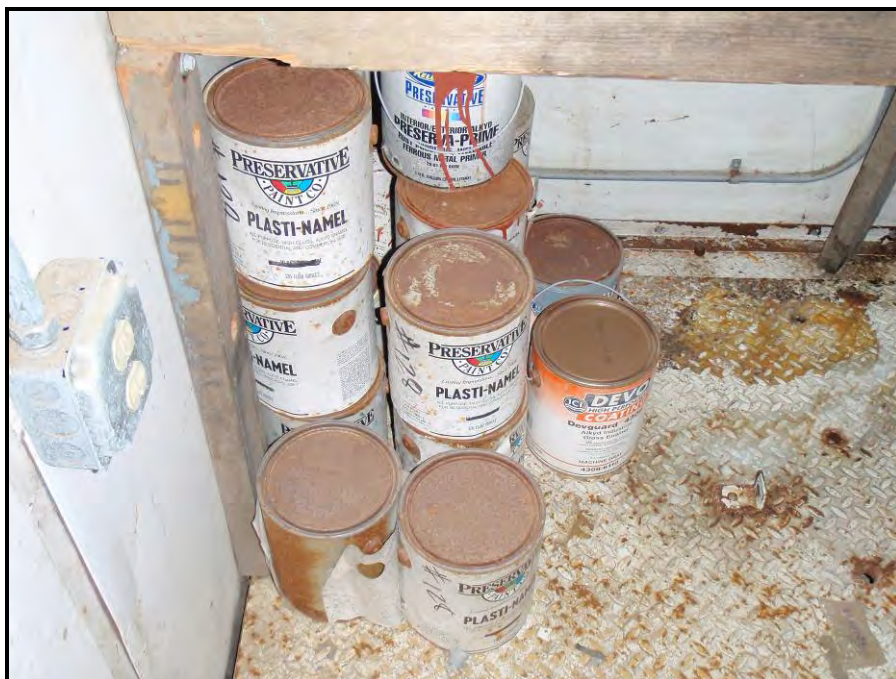
Photograph 12:
Paint found inside the white generator building.

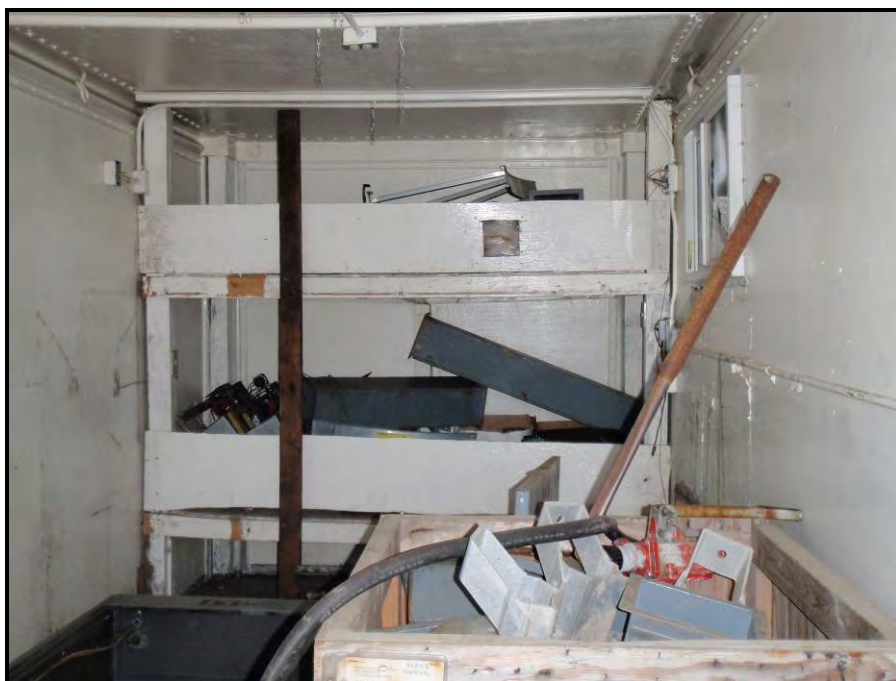
Photograph 13:
Equipment inside the CONEX building.

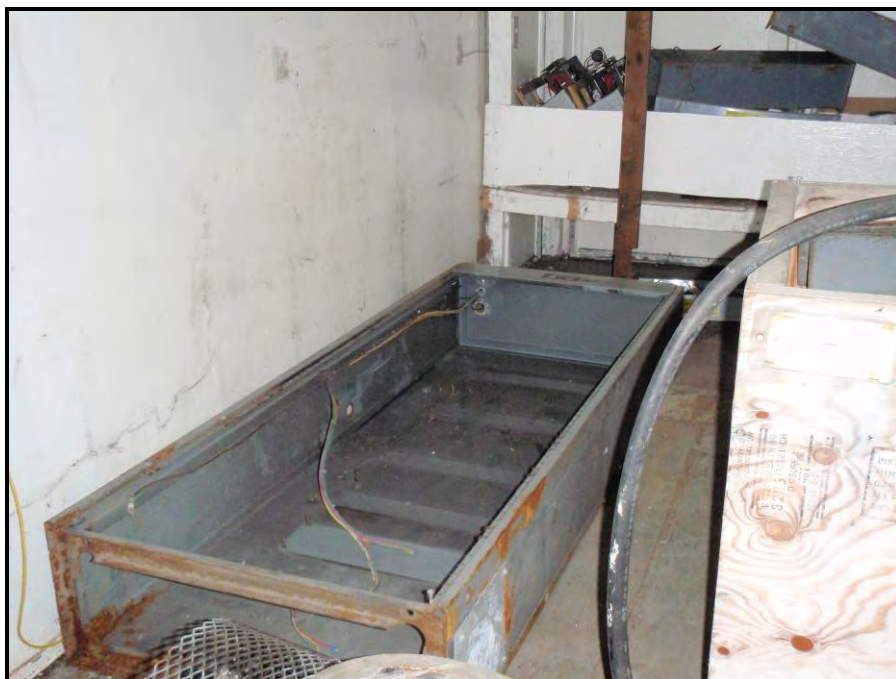
Photograph 14:
Old generator base and electrical equipment present inside the CONEX building.

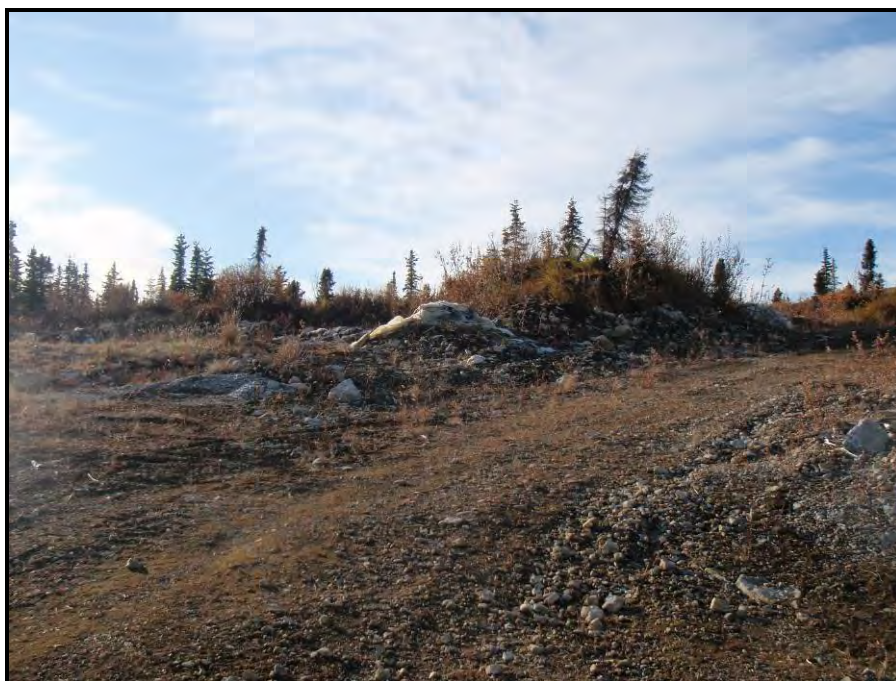
Photograph 15:
Potential soil landfarming area (left half of photograph) at Iron Creek Pit.

- **Landfarming** – This method includes spreading the contaminated soil into a 1-foot thick layer. The soil is tilled periodically during the summer months using a rototiller. Tilling aerates the soils to promote aerobic degradation of contaminants in the soil. The addition of fertilizer is also used to promote biological activity. Initial landfarm characterization samples are collected to document contaminant levels at the time of placement. Characterization samples are collected on an annual basis to determine when cleanup goals are met. The DEC Solid Waste Program will specify the target cleanup thresholds prior to using landfarmed soils as daily landfill cover.
